# Use of Ultra-High-Performance Concrete for Bridge Deck Overlays

**Final Report**  
**March 2018**

**Sponsored by**  
Iowa Highway Research Board  
(IHRB Project TR-683)  
Iowa Department of Transportation  
(InTrans Projects 16-573 and 16-574)  
Federal Highway Administration

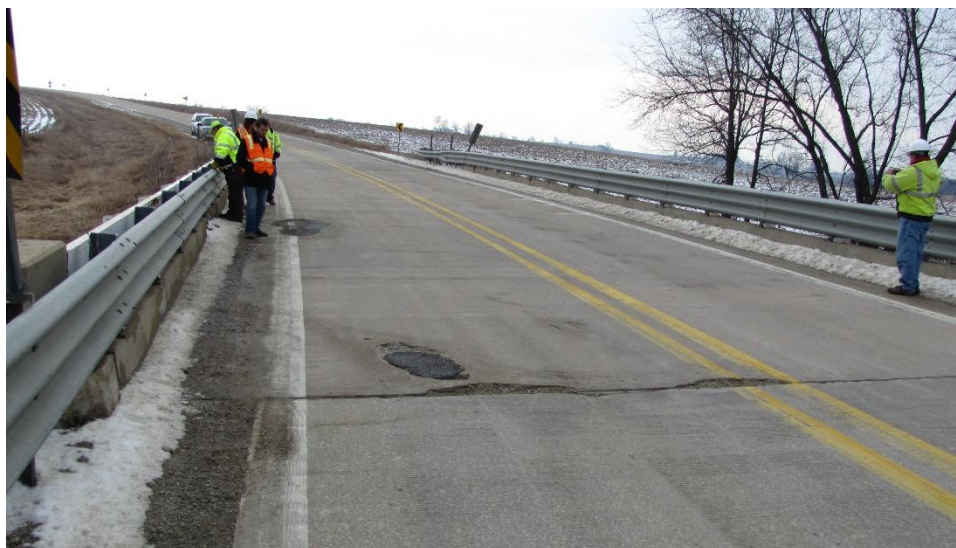
**Figure 3.1. Mud Creek Bridge deck before UHPC overlay application**

Mud Creek Bridge, built in the mid-1960s in Buchanan County, Iowa, was selected for the UHPC overlay demonstration project. The bridge is located between the towns of La Porte and Brandon. This is a three-span, two-lane, straight continuous concrete slab bridge. The bridge is 100 ft long and 28 ft wide. In addition, the bridge has a 5% superelevation. Prior to the UHPC overlay retrofit, the deck of this bridge had some locally damaged regions, as shown in Figure 3.1.

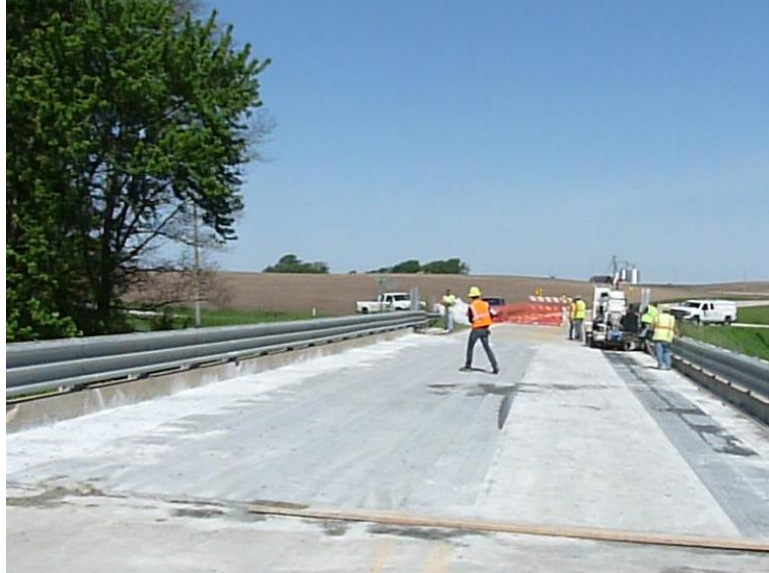
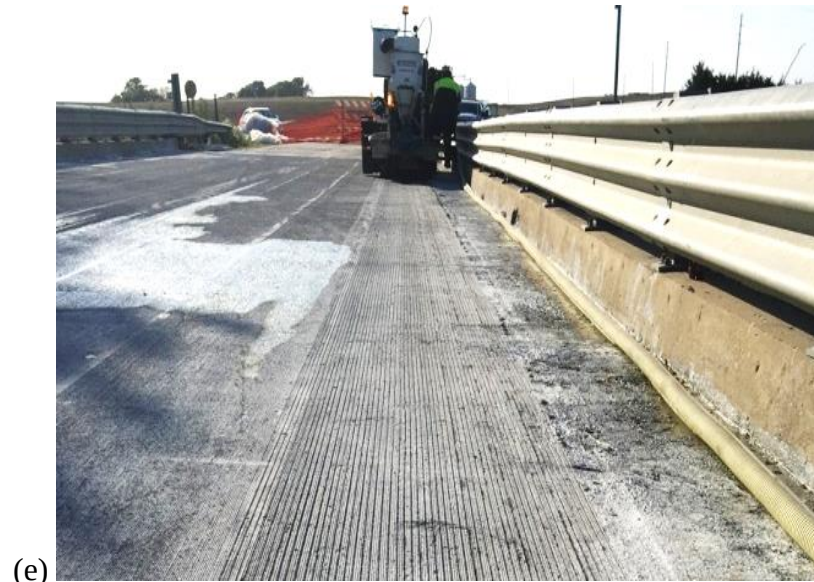
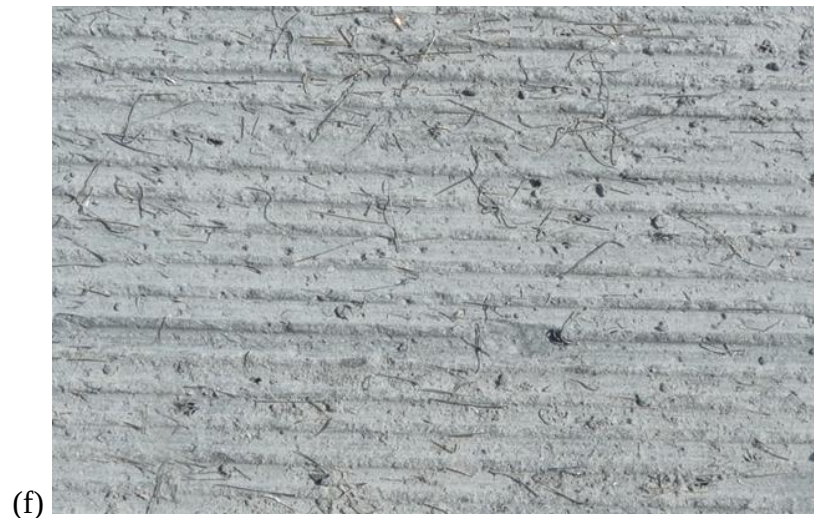
**Figure 3.3. Overlay construction: (a) roughened deck surface prior to placing the overlay, (b) placing of the UHPC overlay with a screed, (c) UHPC overlay after casting one lane, (d) grinding of the surface, (e) grooving of the surface, and (f) close-up view of the finished surface**

Construction began with removal of the old asphalt overlay and the damaged concrete from the deck. Then, the surface of the deck was ground and grooved to expose the aggregate and create a target surface roughness of about 1/8 in. or 3 mm. After that, water was sprayed on the deck surface and rebars were placed at the pier locations. Then, the UHPC overlay was placed on top of the deck along the entire length of one lane to avoid the formation of construction joints in the transverse direction. A regular vibratory concrete screed was used for placing the material, and a concrete curing compound was sprayed on top of the UHPC overlay immediately afterwards. A few days later, UHPC overlay construction was performed on the other lane, with a construction joint along the centerline of the bridge. No special detailing was adopted for the construction joint. Once the UHPC hardened, the surface was ground and grooved to give the appropriate roughness for vehicular traffic. Some of the construction pictures are presented in Figure 3.3.

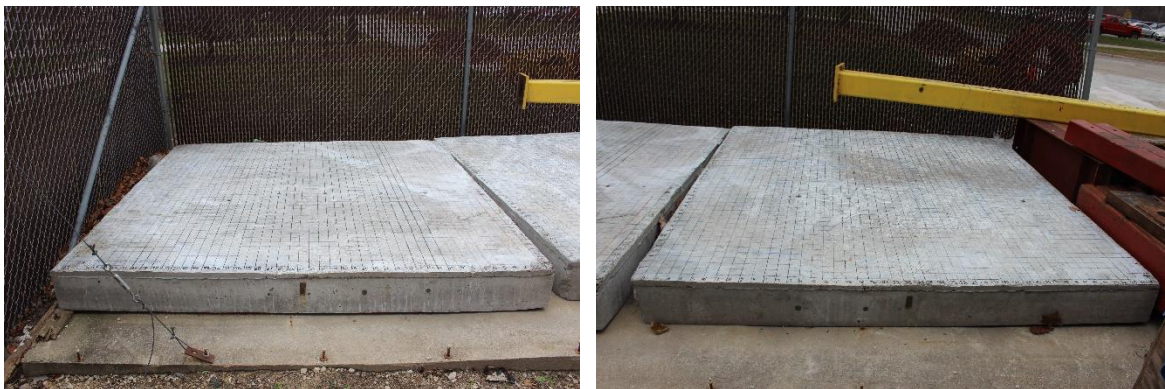
**Figure 3.8. Test specimens placed outside of the laboratory: Slab A (left) and Slab B (right)**

When the slabs were 43 days old, a 1.5 in. thick UHPC overlay was placed on the top of each slab on July 22, 2015. In both cases, the slabs were positioned at a 6% slope to ensure that the UHPC overlay could be placed on sloping surfaces. Curing of the slab specimens and overlays was performed inside the structural laboratory. Afterwards, the slab specimens were moved to an outdoor location for environmental exposure, as shown in Figure 3.8.

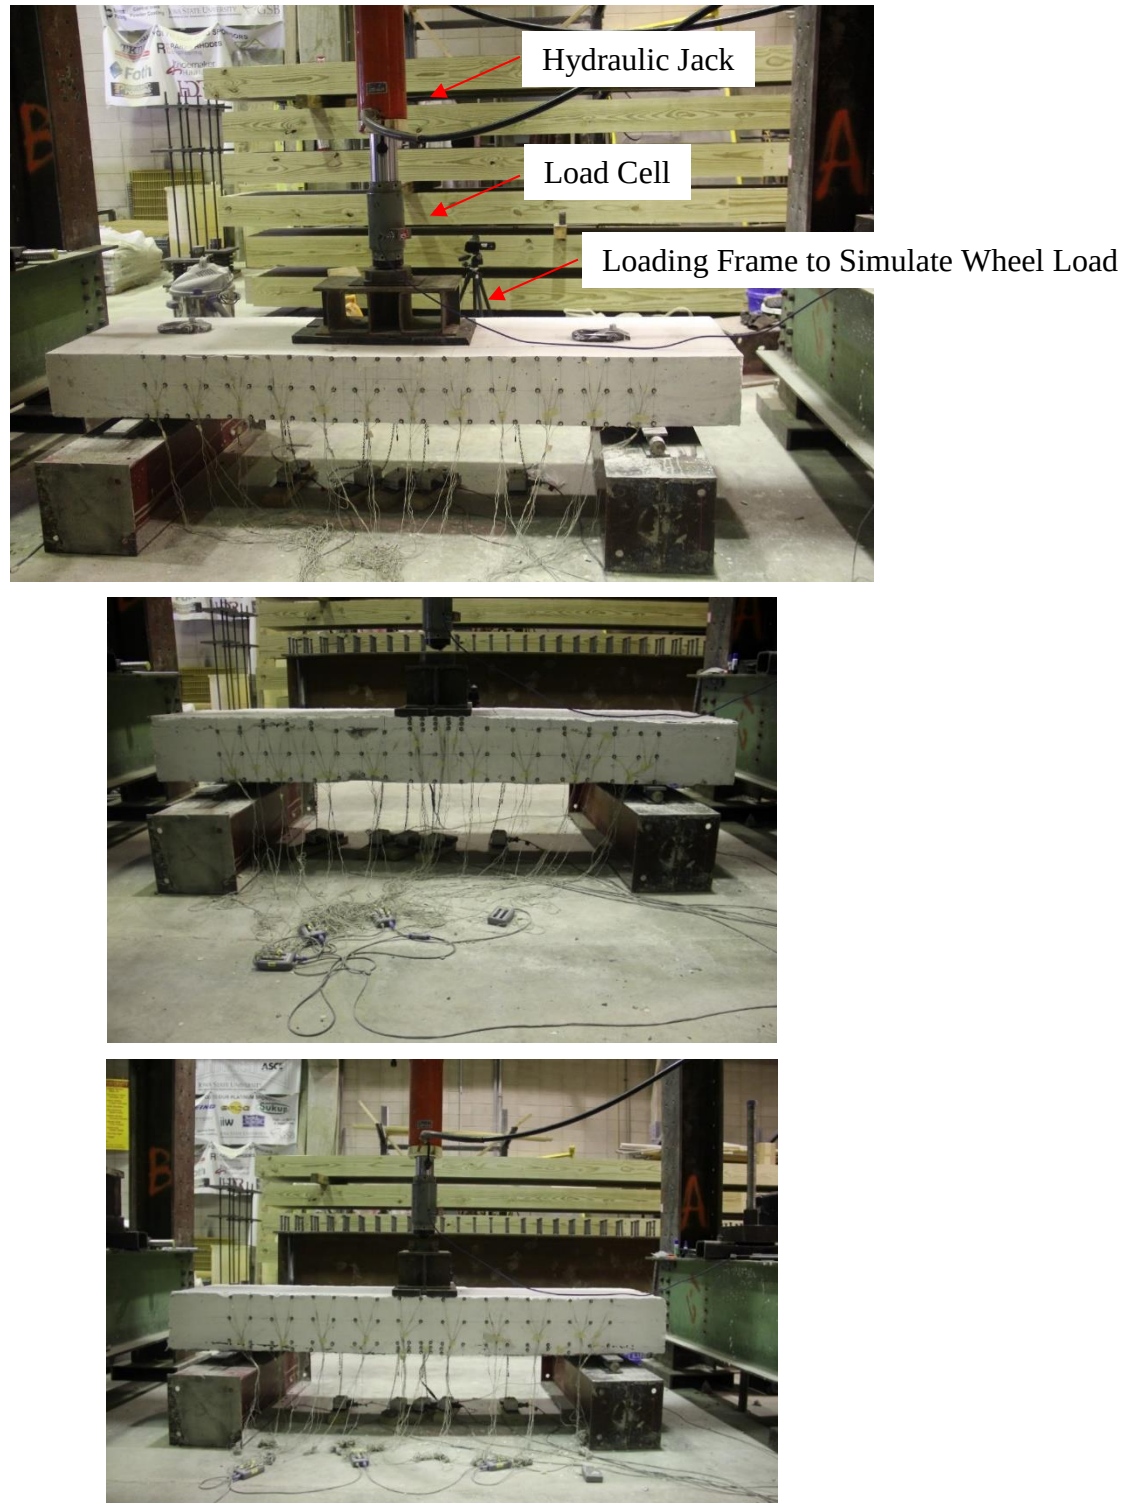
Figure 4.3. Test setup for Specimens NO (top), OT (center), and OB (bottom)

The test setup for all three cases is shown in Figure 4.3.
