# Analysis of Dynamic Advisory Messaging – Phase II

**Final Report  
August 2018**

Center for Transportation  
Research and Education

**Sponsored by**  
Iowa Statewide Transportation Innovation Council  
Iowa Department of Transportation  
(InTrans Project 16-591)

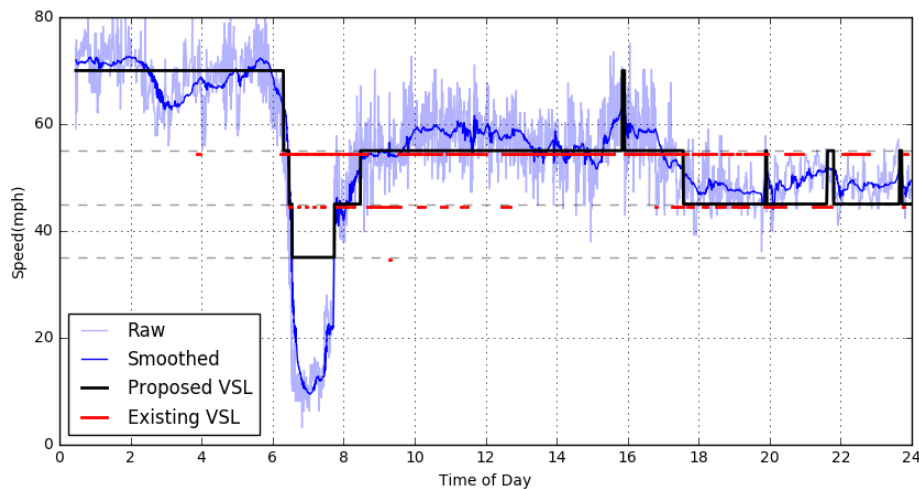
**Figure 1. Proposed versus existing logic**

The research team compared the existing logic to the new logic (proposed algorithm) developed in Phase I. Figure 1 shows a comparison for a specific weather event between the existing logic (red line) and the proposed advised speed limit control logic (black line).

When a big snow event hit the roadway, between 6 a.m. and 8 a.m., most drivers were traveling at a speed below 20 mph. During this time, the existing logic advised a speed limit of 45 or 55 mph as compared to the proposed logic that advised a more reasonable speed limit of 35 mph.

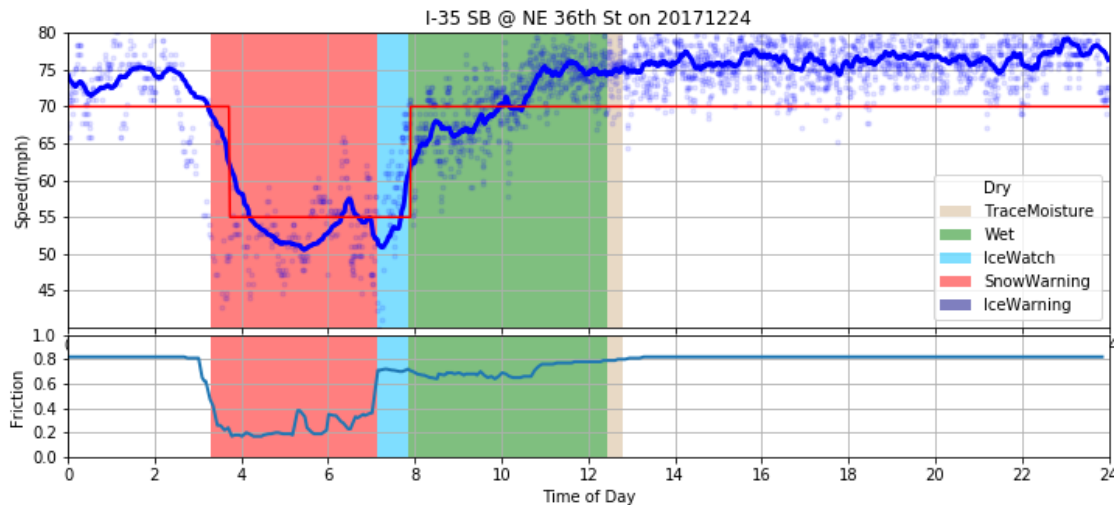
**Figure 2. Event #1 at I-35 SB @ NE 36th St: Speed profile and roadway surface condition**

A snow event on December 24, 2017 impacted I-35 near the NW 36th Street interchange. Figure 2 shows the measured traffic sensor (upper chart) and friction data (lower chart).

As shown, speeds dropped at around 3 a.m., hovered around 50 mph between 5 a.m. to 8 a.m., and then gradually returned to normal around noon. In the chart in Figure 1, the light blue points were raw sensor data and the solid blue line represented smoothed speeds used to trigger the advisory messages (straight red line). The new algorithm successfully displayed the message of “Advised 55 mph” between 3 a.m. to 7 a.m. This was further validated using the TransSuite Traveler Information System (TIS) software report. The friction conditions illustrated a similar pattern, changing from the worst condition of snow warning from 3:30 a.m. to 7:15 a.m., then to ice warning from 7:15 a.m. to almost 8 a.m., to wet, trace moisture, and then finally, dry.

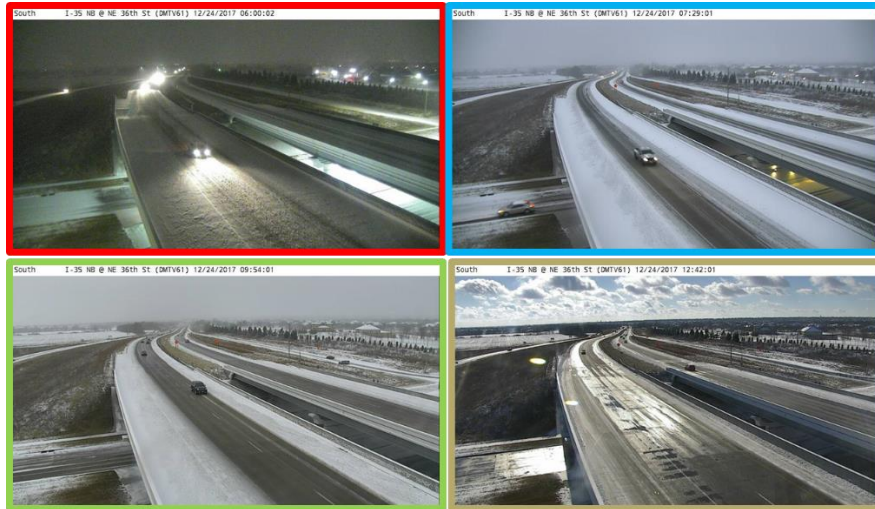
**Figure 3. Event #1 at I-35 SB @ NE 36th St: Roadway surface conditions**

In addition to the quantitative description, the research team downloaded the nearby camera images during the event. Figure 3 shows this location’s camera view; from top left to bottom right, it shows the conditions of snow warning, ice watch, wet, and trace moisture, respectively. The color bordering each camera image can also be related to the friction color shading in Figure 2.

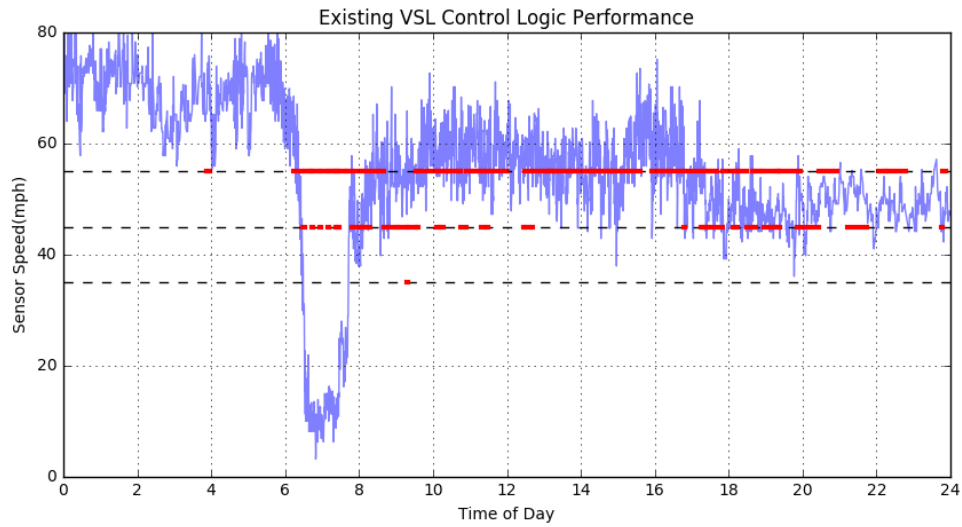
**Figure 4. Performance of existing VSL control logic**

The existing logic used to generate sensor-based messages (in this case advisory speeds) is not designed for the task. Figure 4 displays three advisory speeds, shown as dashed lines, 55 mph, 45 mph, and 35 mph. The solid red lines are messages, which would have appeared on a dynamic message sign.

Figure 4 indicates room for improvement, especially from 6 a.m. to 8 a.m., when the speed had already dropped to 10 mph due to the severe snow, but the existing control logic was still posting messages of 55 mph or 45 mph.

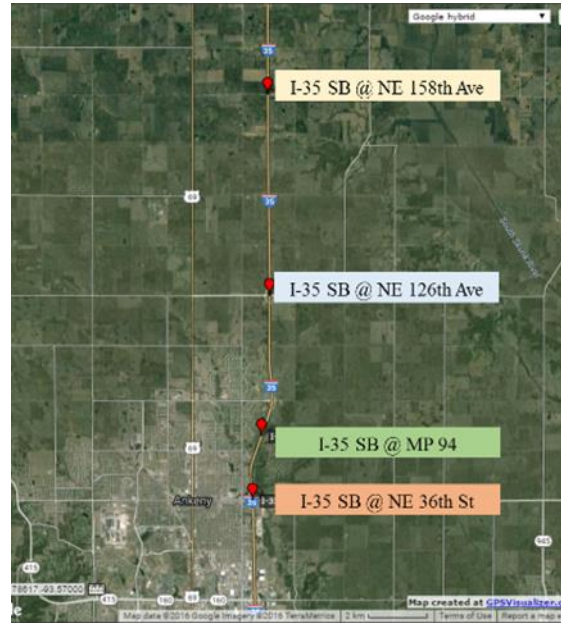
**Figure 6. Dynamic advisory corridor and sensors**

Figure 6 shows the study corridor of southbound I-35 between Huxley and Ankeny with four Wavetronix sensors installed.

These sensors were associated with four virtual simulated DMS display boards: (1) SIM I-35 NB @ Millis Civic-OH, (2) SIM I-35 SB @ Corp Woods-OH, (3) SIM I-80 EB @ Jordan Creek-OH, and (4) SIM I-35 WB @ 4-Mile-OH. By operating these virtual message boards in the background without display messages, the researchers could verify the accuracy of the messages before deployment. The posted speed limit for this corridor is 65 mph for the two southern sensors and 70 mph for the two northern sensors. Table 1 shows the sensor listings used along with their association with TransSuite Traveler Information System (TIS) software communication.

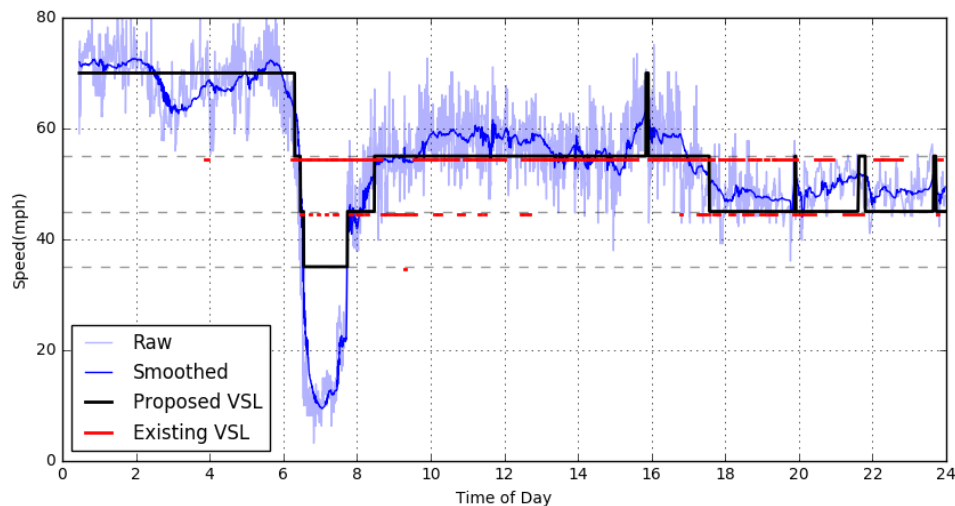
**Figure 8. Proposed logic versus existing logic**

Comparisons between the proposed advised speed limit control logic (black line) and the existing logic (red line) for a weather event are shown in Figure 8.

The raw speed data and smoothed speed data using wavelet transformation were plotted as light blue and dark blue lines, respectively. As for the three performance measures, the proposed logic generated 0 clusters, 0 short messages, and 13 total messages compared with 12 clusters, 27 short messages, and 120 total messages generated with the existing logic for the winter weather event in Figure 8. In addition, a closer look at the period between 6 a.m. to 8 a.m., showed a large speed drop due to a severe snow event and revealed that the proposed logic improved the relevance of the advisory messaging. Although most drivers were traveling at a speed below 20 mph, the existing logic still advised a speed limit of 45 or 55 mph. On the other hand, the proposed logic correctly detected the severe traffic condition and provided a more reasonable advised speed limit of 35 mph.

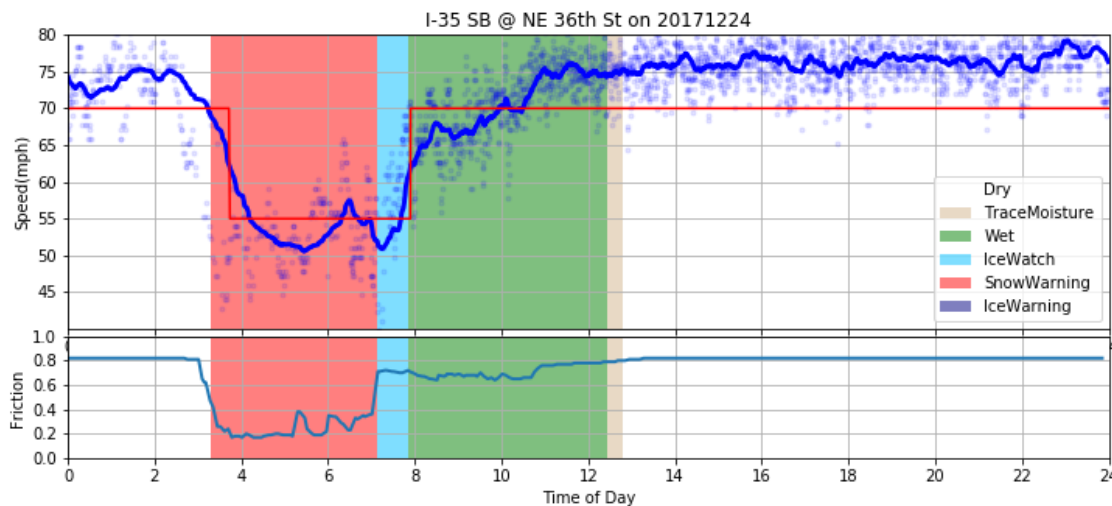
**Figure 10. Event #1 at I-35 SB @ NE 36th St: Speed profile and roadway surface condition**

A snow event on December 24, 2017 had snow conditions between 1 a.m. and 11 a.m. Figure 10 shows the sensor data during the winter snow event near the 36th Street interchange.

The speed started to drop around 3 a.m., hovering around 50 mph between 5 a.m. to 8 a.m., and gradually returned to normal by noon. Meanwhile, the friction conditions illustrated a similar pattern—changed from the worst condition of snow warning/ice watching to the normal situation (wet and trace moisture, then dry). In the top plot of Figure 10, the light blue points were raw sensor data and the solid blue line was smoothed speed that was used to trigger the advisory messages (straight red line). The new algorithm successfully displayed the message of “Advised 55 mph” between 3 a.m. to 7 a.m. This was further validated using the TransSuite TIS Software Report in Figure 11.

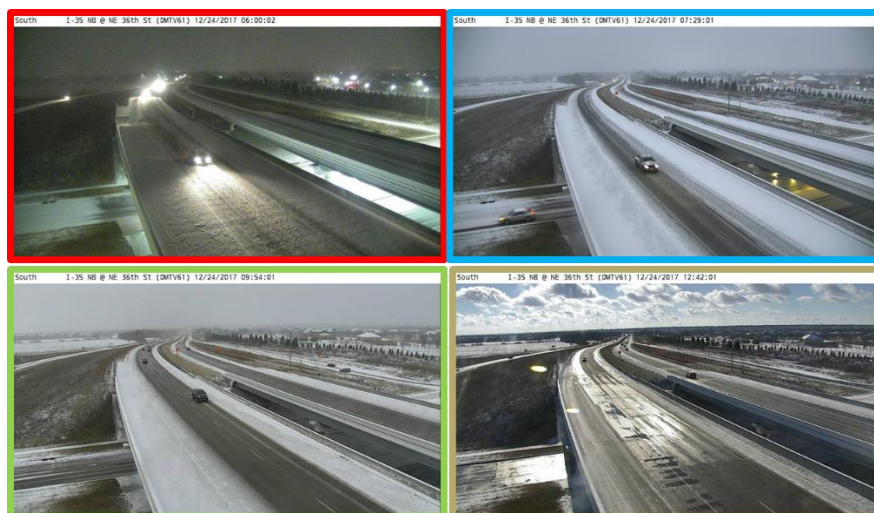
**Figure 12. Event #1 at I-35 SB @ NE 36th St: Roadway surface conditions**

Besides the quantitative description from the sensor/report, the research team also downloaded the nearby camera information for better visualization. Figure 12 shows the camera view for the roadway surface at this location on the same day. From top left to bottom right, it shows the conditions of snow warning, ice watch, wet, and trace moisture, respectively. The color bordering each camera image can also be related to the friction color shading in Figure 10.

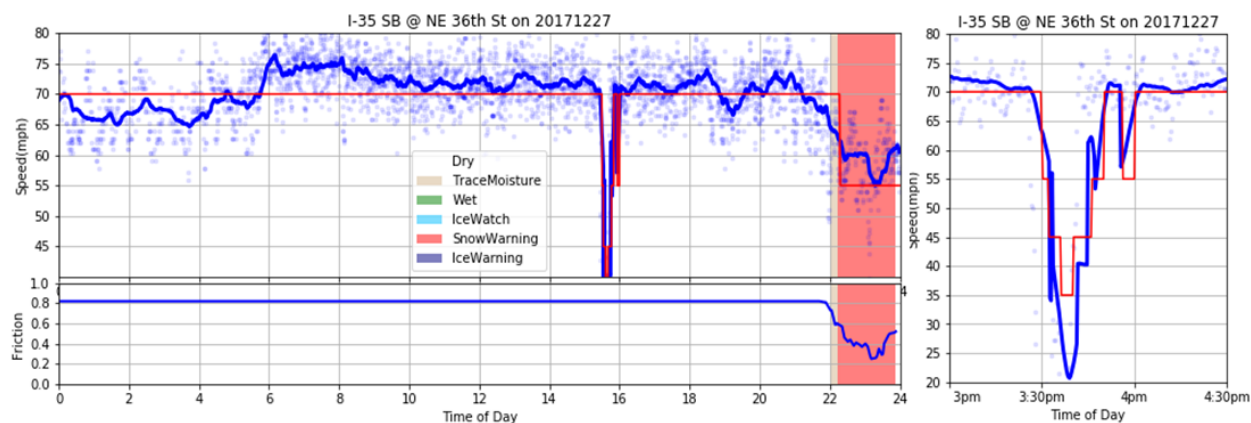
**Figure 13. Event #2 at I-35 SB @ NE 36th St: Speed profile and surface condition**

Figure 13 illustrates the speed profile at the 36th Street interchange, where the red patched region indicates the snow warning logged by the roadway friction sensor.

This event started around 10 p.m., but speeds were beginning to slow down before that due to the roadway surface conditions. The advisory messaging logic detected the slow down at 10:20 p.m. (as the TIS report in Figure 14) and displayed an advisory 55 mph message accordingly.

One highlight from the plot is that, besides responding to the snow storm, the new algorithm also reacted correctly to a crash around 3:30 p.m. The traffic conditions during the accident are visible in Figure 13 on the right, where the speed dropped to 20 mph. A nearby camera's

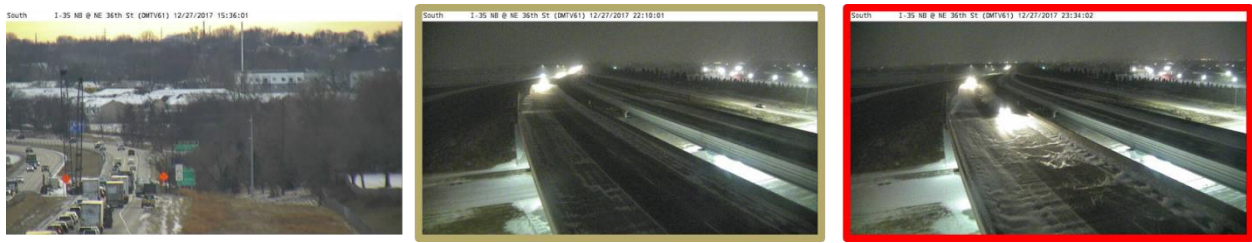
**Figure 15. Event #2 @ I-35 SB @ NE 36th St: Camera images of roadway conditions**

imagery data were also retrieved to double-check the algorithm's accuracy, as illustrated in Figure 15.

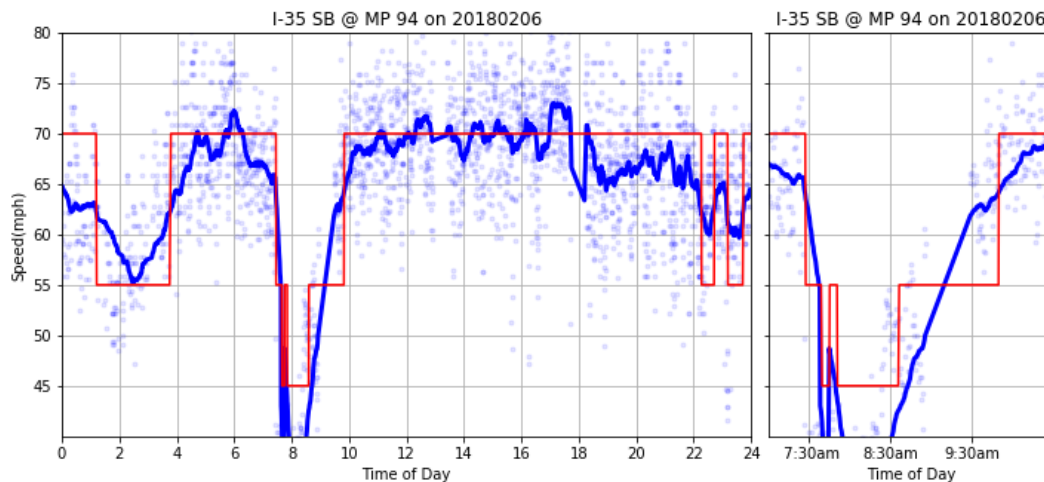
**Figure 16. Event #3 at I-35 SB @ MP 94: Speed profile**

The speed profile in Figure 16 reflects the weather conditions.

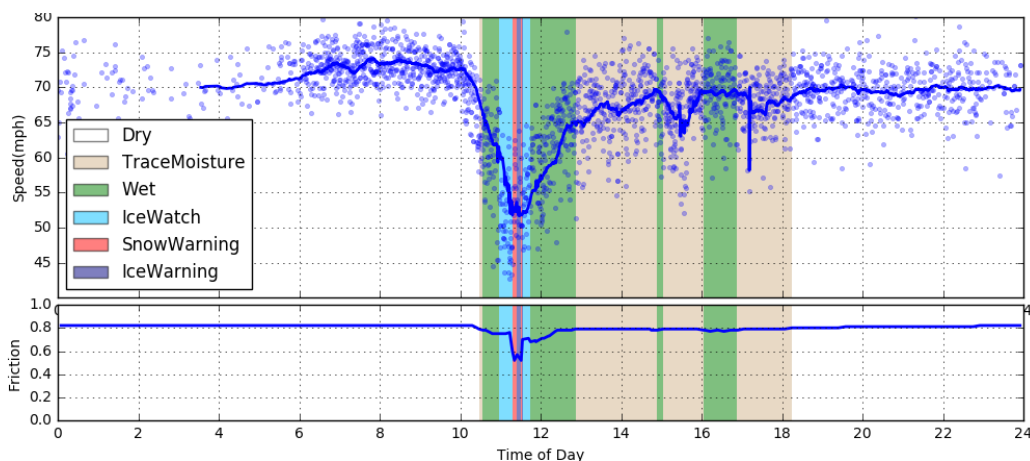
**Figure 18. Site #1 on December 24, 2015**

Figure 18 shows that vehicle speeds were decreasing prior to any change in reported surface condition (speed decreased around 10 a.m., which was roughly 30 minutes before the friction sensor detected that the road was wet).

The Figure 18 lower line plot indicates surface changes around the same time as speeds began to decrease, but were not changed enough to trigger a wet or icy condition (vertical shading). In this case, it appears that speed provided a better indicator of deteriorating conditions. An RWIS sensor in the Ames area was also used as a baseline to confirm the surface conditions reported for December 24 and 28.

Figure 18 and Figure 19 show the speed and friction data at Site 1 on December 24 and 28, 2015, respectively. The friction sensor for Site #1 is about 2 miles north of the speed sensor. The upper plot in each figure shows the raw speeds (light blue points) and the smoothed speed (solid blue line). The lower (line) plot shows the friction sensor values and the (vertical) shading represents the reported surface condition, which is generated by the sensor (see legend).

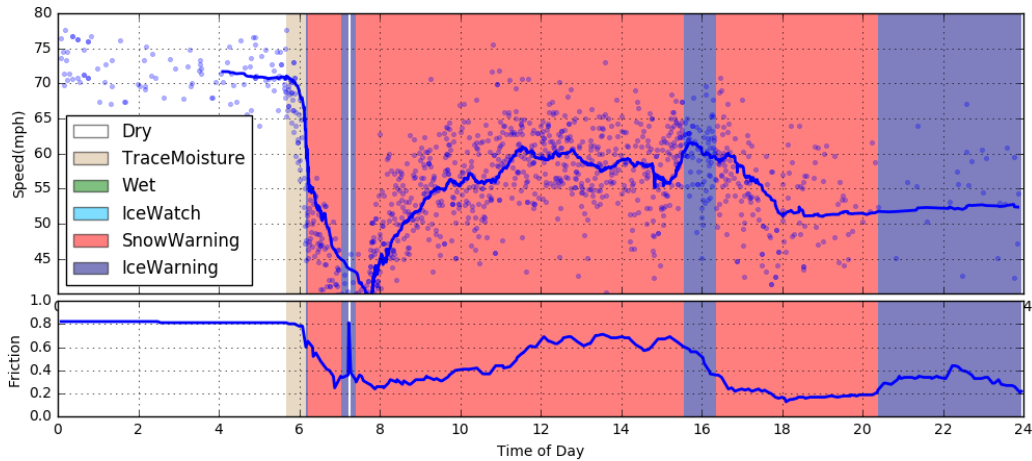
**Figure 19. Site #1 on December 28, 2015**

Figure 19 shows the speed and friction data during the December 28, 2015 winter event.

As shown, prior to 6 a.m. the friction sensor identified trace moisture (brown vertical shading) while speeds were still at free flow; however, speeds began to drop off and continued to decrease as the snow warning was identified after 6 a.m. In this case, both sensors appeared to detect the change in condition around the same time. There was also a time around 7 a.m. where the friction sensor peaked and reported a dry condition. This was likely due to a snowplow passing through with no observed impact on speeds.

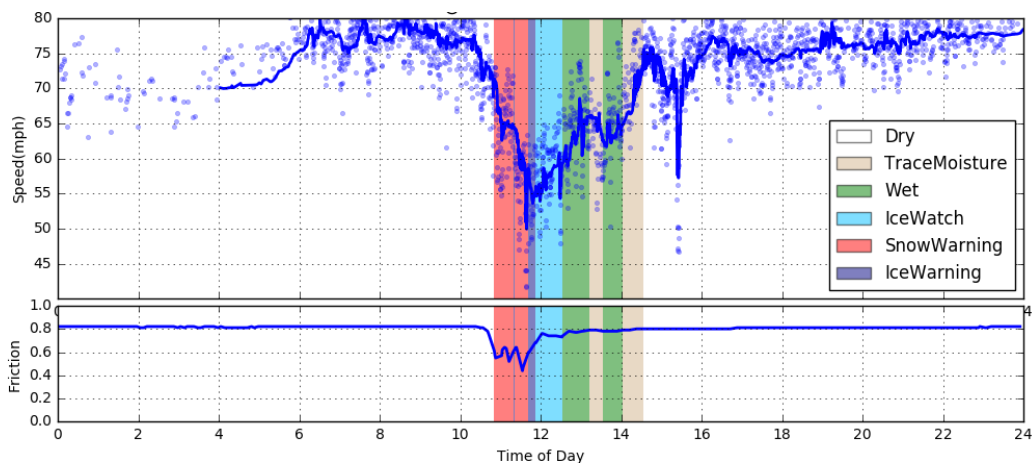
**Figure 20. Site #3 on December 24, 2015**

Figure 20 shows the sensor data for Site #3 during the winter event of December 24, 2015.

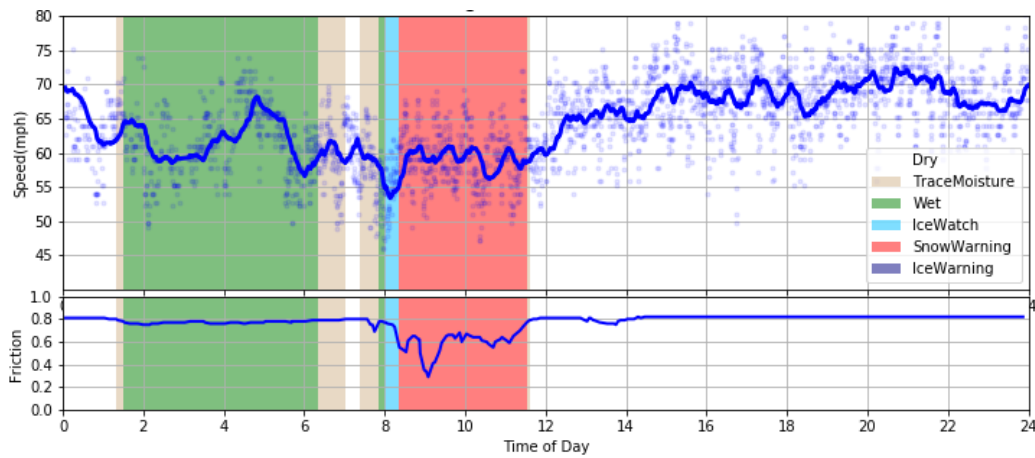
**Figure 21. Site #1 on January 11, 2018**

Figure 21 illustrates another snow event for Site #1 on January 11, 2018; however, the speed did not drop significantly due to the weather.

The relatively low speed between 2 a.m. to 6 a.m. was probably due to the wet road conditions and slow driving trucks. The weather during the morning was getting worse, the sensor was signaling a warning of snow, and drivers were driving at lower speeds (~60 mph). Figure 22 shows the roadway surface conditions of wet, ice watch, and snow warning, from left to right. The speed remained relatively the same for the entire duration of the winter event but would not have captured the variance in conditions as reported by the friction sensor.

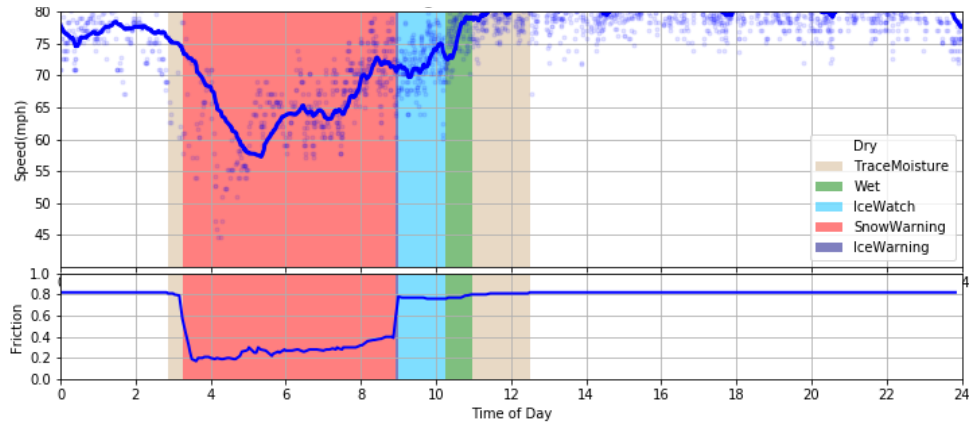
**Figure 23. Site #2 on December 24, 2017**

Site # 2 is about 2 miles to the north of Site #1 and its speed profile in Figure 23 was similar to Site #1 on December 24, 2017.

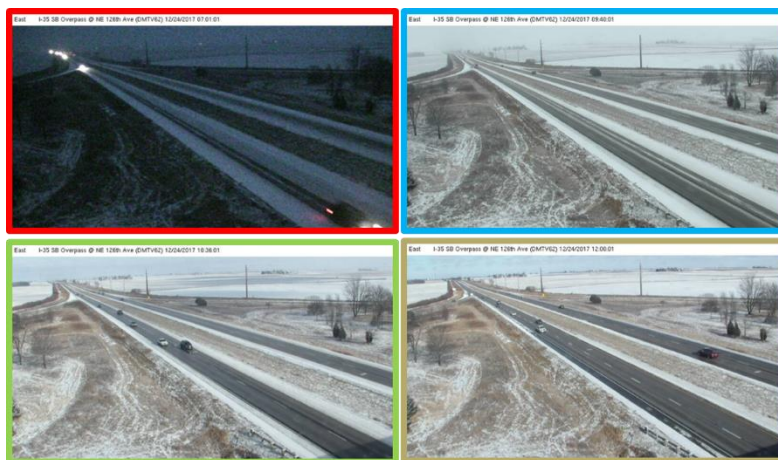
**Figure 24. Roadway surface conditions of Site #2 on December 24, 2017**

Figure 24 shows a similar pattern where roadway surface conditions changed from the worst snow warning level to trace moisture and back to normal dry conditions in afternoon.

Speeds began to drop around the same time as the friction sensor but did not decline as significantly as the friction sensor was reporting. This is an example where the friction sensor was a better indicator for reporting of the road conditions. Note that at 8:56 a.m., the sensor reported a quick warning to watch out for ice, where the friction factor was about 0.6. There was no observed evidence (speed, friction factors, cameras, etc.) indicating this inclement weather event. Additional information as to how the conditions were detected by the sensor may be needed to understand why conditions were reported as ice watch.

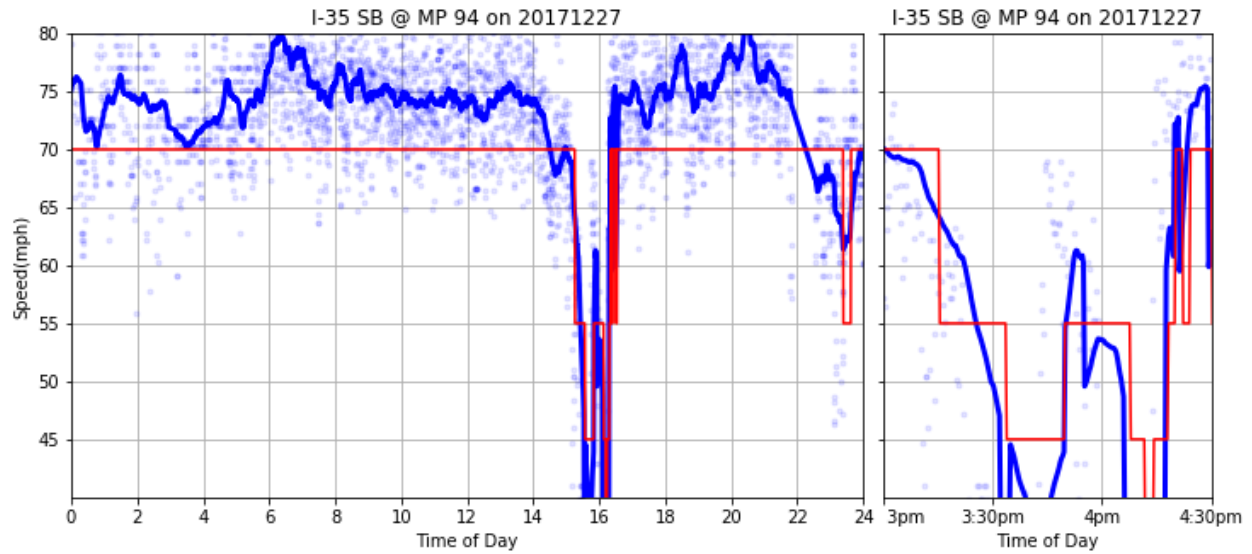
**Figure 25. Event #2 @ I-35 SB @ MP 94: Speed profile**

The sensor at MP 94 is about 1 mile to the north of 36th Street and the crash that happened at 36th Street propagated back to this site as well. There was a significant speed drop due to the abnormal traffic event and the advisory logic displayed proper advisory messages of 55 mph, 45 mph, and 35 mph based on different traffic conditions (as evidenced in Figure 25 and Figure 26). Around 4:30 p.m., the traffic returned to normal, and the advisory logic turned off (displaying 70 mph).

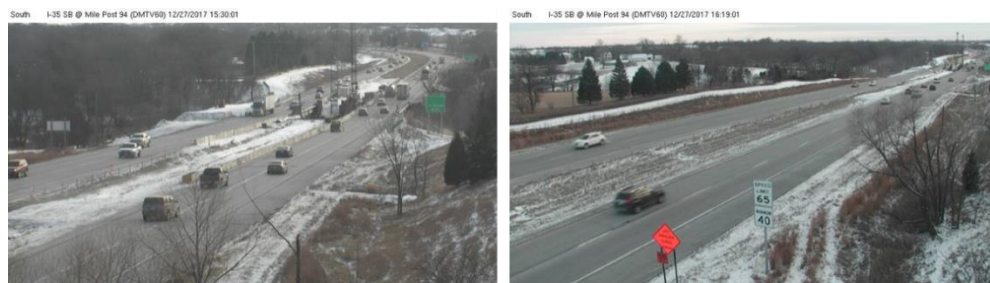
**Figure 26. Event #2 @ I-35 SB @ MP 94: Camera view of traffic event**

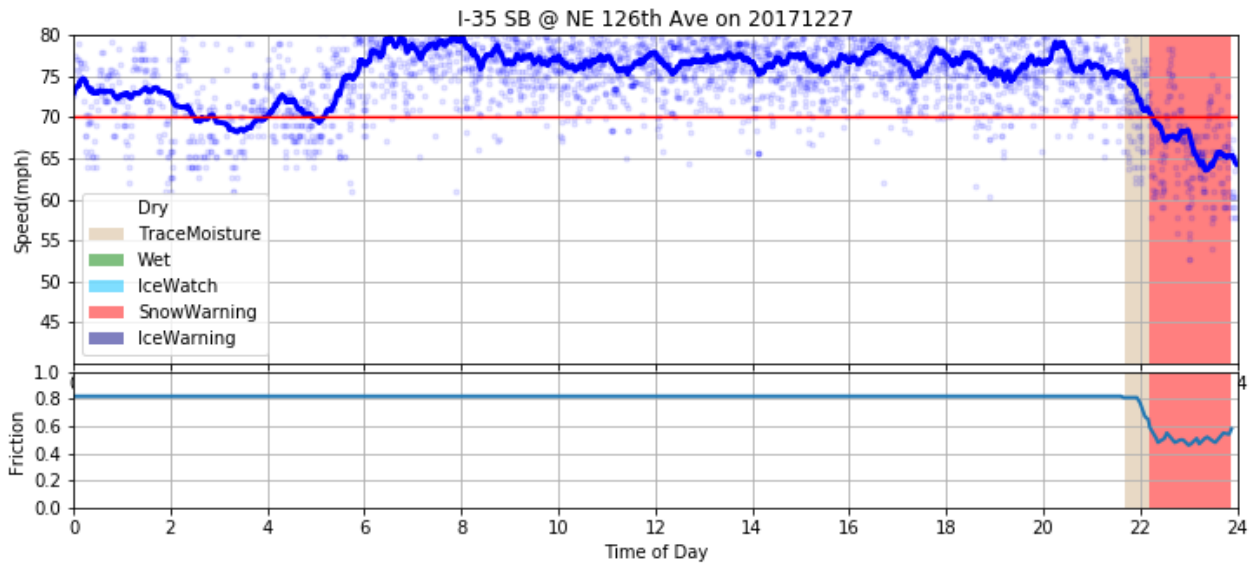
**Figure 27. Event #2 @ I-35 SB @ NE 126th Ave: Speed profile and surface condition**

Figure 27 profiles the remaining site where during Event #2 drivers were slowing down at night due to the light snow event but the traffic conditions (determined by speed and sensor occupancy) were not severe enough to trigger the advisory message of 55 mph. Hence, the advisory logic did not generate messages while the friction sensor site did show a snow warning alert.

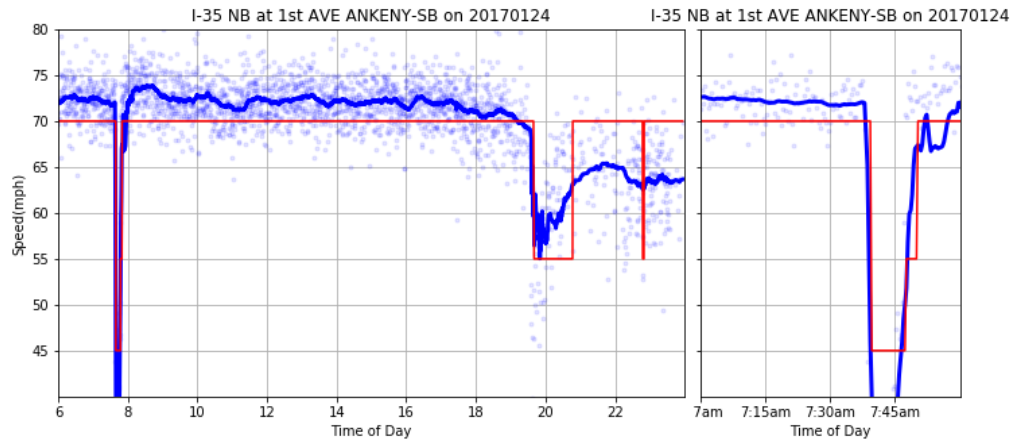
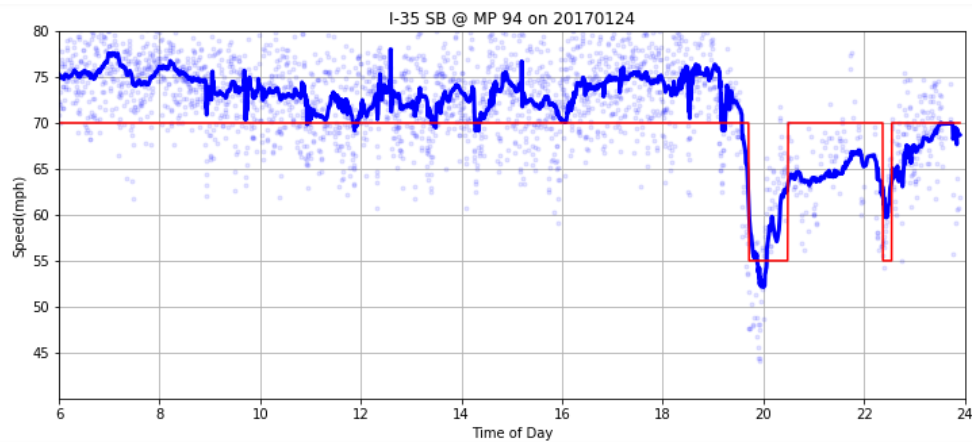
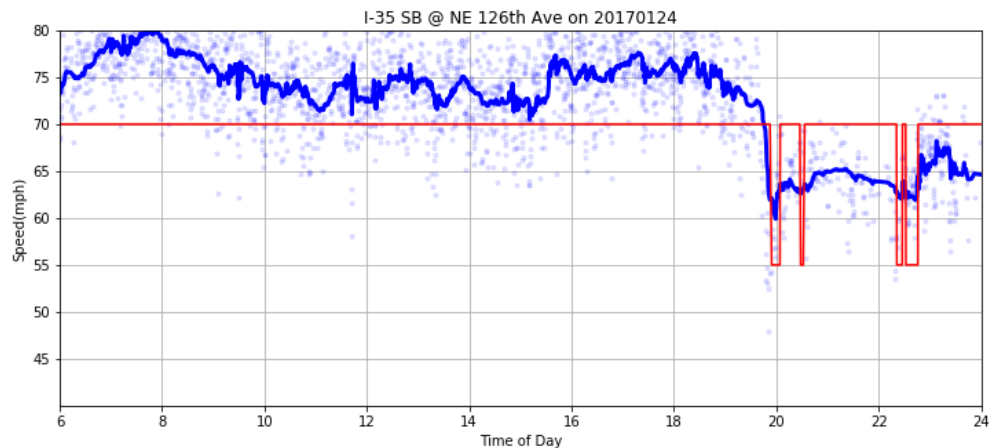
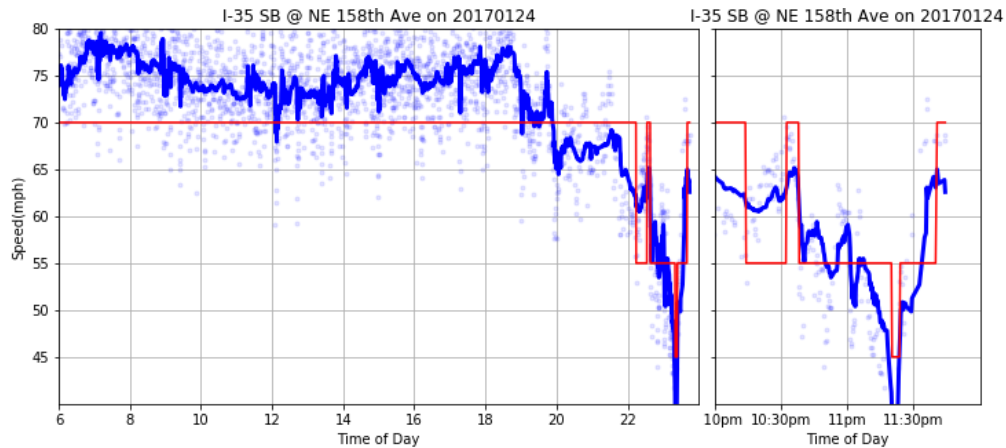
Figure 28, Figure 29, Figure 30, and Figure 31 show the speed profiles for each site as well as the displayed messages represented by the red line. It was apparent that drivers reduced their speed when the winter weather event started after 7 p.m. for all sites, which was consistent with the beginning of snowfall on that day. The advisory logic responded appropriately to the traffic and displayed the advisory speed messages of 55 mph. The advisory logic significantly reduced the fluctuation in messages, which were generated through the previous alerting system.

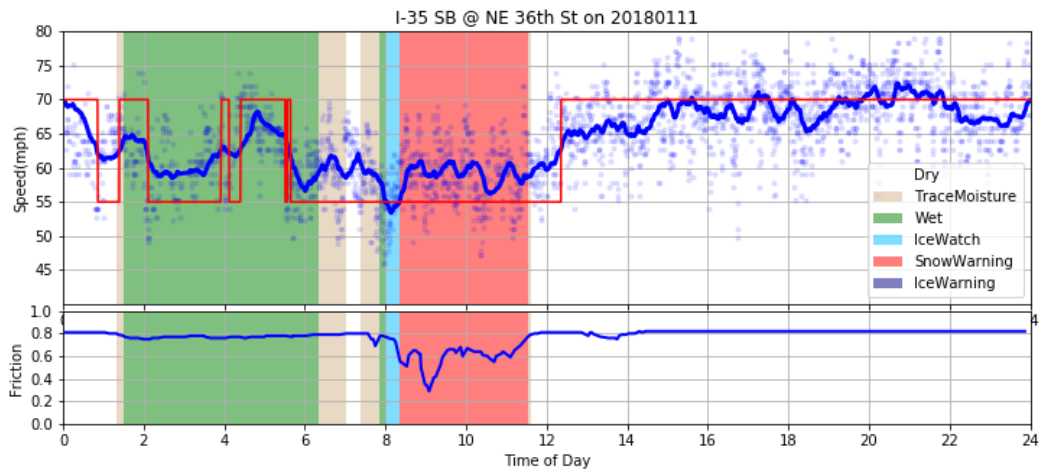
**Figure 32. Event #5 @ I-35 SB @ NE 36th St: Speed profile and surface condition**

Due to the inclement weather and bad roadway surface conditions, most of drivers were choosing a relatively lower speed. Figure 32 visualizes the speed profile, friction factors, and displayed 55 mph messages for most of morning time period.

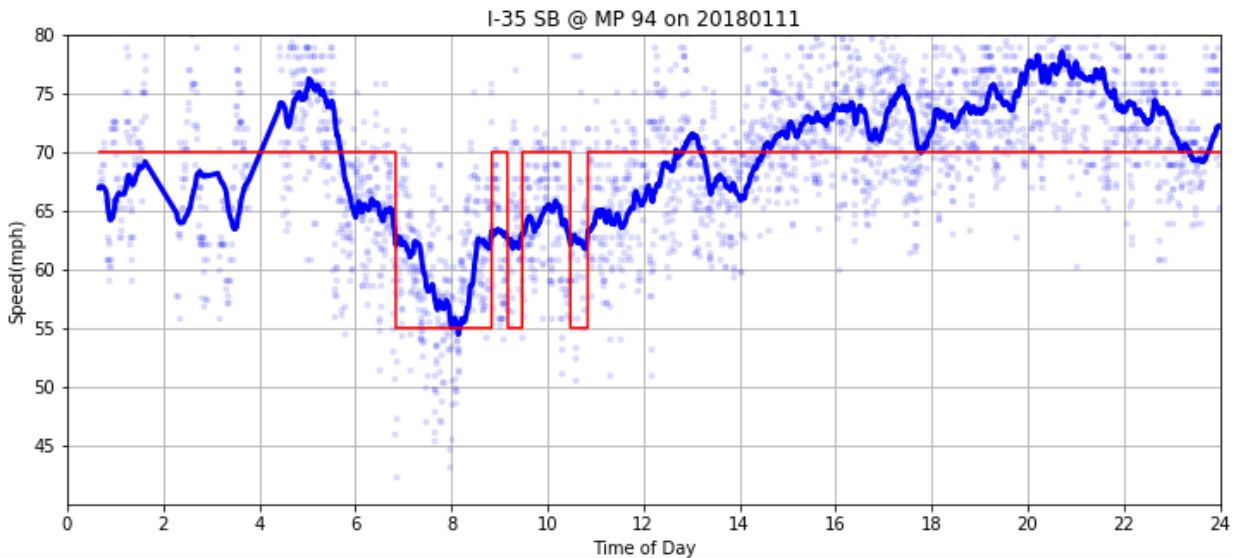
**Figure 33. Event #5 @ I-35 SB @ MP 94: Speed profile**

Unlike 36th Street, this site still had higher observed speeds (~ 65 mph) during the early morning; thus, the advisory logic was not triggered until 7 a.m. (Figure 33). This advisory messaging lasted for about 2 hours until 9 a.m. After the morning peak, as speed and occupancy improved, there were two additional minor speed drops, which triggered the advisory messaging of 55 mph.

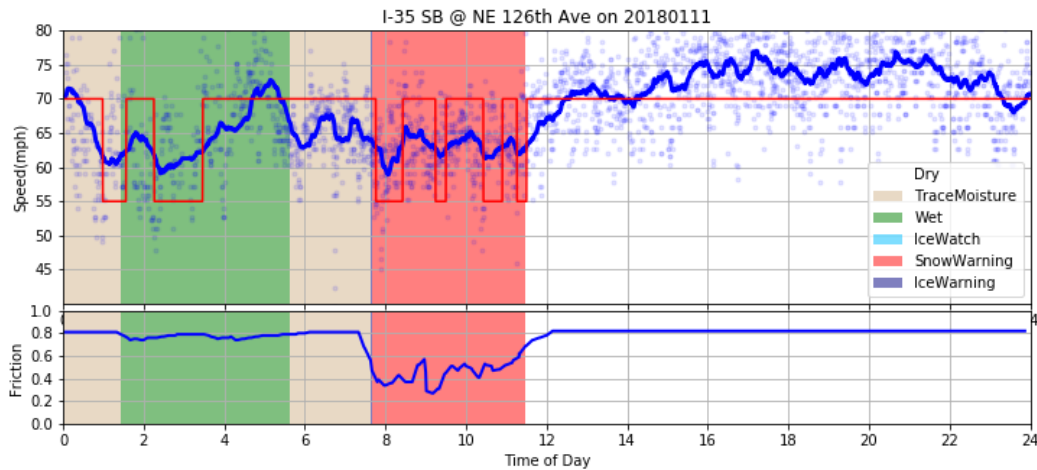
**Figure 34. Event #5 @ I-35 SB @ NE 126th Ave: Speed profile and surface condition**

Drops in speed were sporadic at NE 126th Avenue as shown in Figure 34. The advisory logic detected the speed trend and responded with 55 mph advisory messages as shown in Figure 34. Note there was another speed drop around 6 a.m.; however, it was still around 65 mph, which was not significant enough to trigger the messaging system. Compared to the friction sensor, the advisory messaging was sporadic between 8 a.m. and 12 p.m. The raw friction factors (shown in the bottom plot) also showed varying friction factors during this time but were not significant enough to change the snow warning condition.

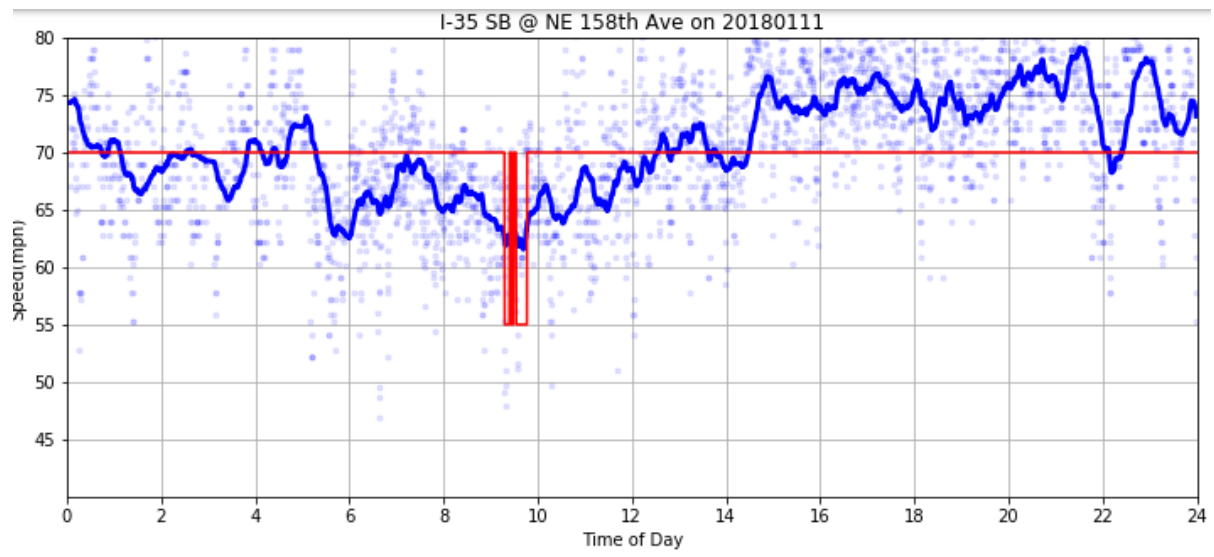
**Figure 35. Event #5 @ I-35 SB @ NE 158th Ave: Speed profile**

The traffic conditions at 158th Avenue are illustrated in Figure 35. Overall, the speed profile matched the weather conditions with slower speeds during the morning due to snow, and higher speeds during afternoon when the weather was getting better without snow. There was a message cluster around 9:30 a.m., which was likely due to the unstable/complex traffic conditions (determined by both speed and occupancy). Note that the current message display limit was 2 minutes, a longer setting of display time (for example, forcing the message to display at least 5 minutes) might eliminate the clustering effect.

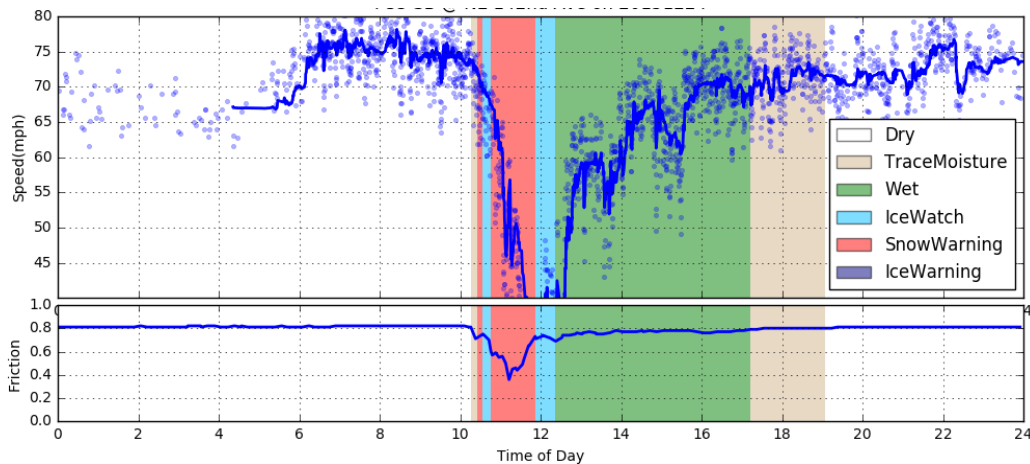
**Figure 36. Site #2 on December 24, 2015**

Figure 36 and Figure 37 show the speed and friction data at Site #2 for the winter events of December 24 and 28, 2015, respectively. For Site #2, the friction sensor is located approximately 1 mile north of the speed sensor. In Figure 36, the speed and friction data both begin to drop at approximately the same time.

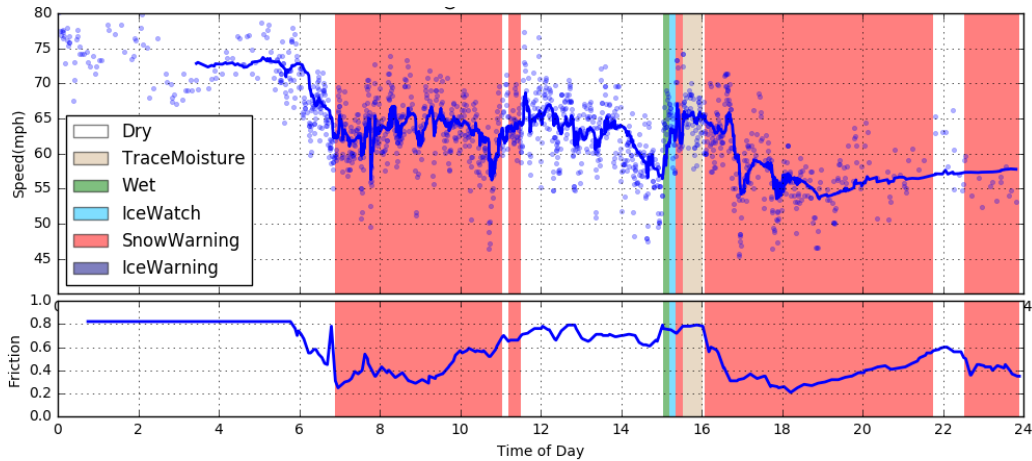
**Figure 37. Site #2 on December 28, 2015**

Figure 37 shows speeds slowing down just before 6 a.m., and the friction data began dropping around the same time, but do not show a road condition change or snow warning until almost an hour after speeds began dropping. A spike in friction data, at around 7 a.m., was likely due to a snow plow. Also of interest, during the snow storm the friction sensor showed dry conditions multiple times with significant gaps between 12 a.m. (midnight) and 3 p.m. and again around 10 p.m. Speeds during all of these time periods remained variable and below the free flow speeds, which was in contrast to the dry condition reported by the friction sensor.

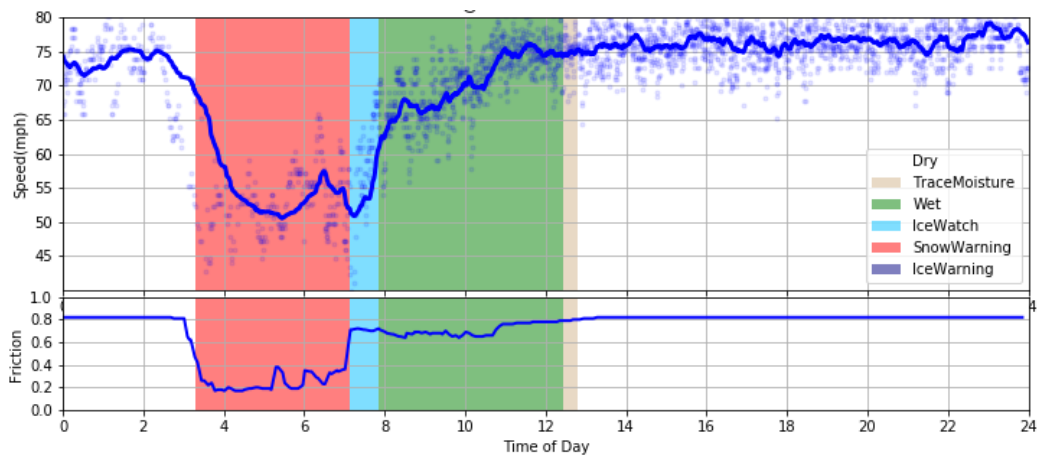
**Figure 38. Site #1 on December 24, 2017**

Figure 38 shows the sensor data for Site #1 during one winter snow event on December 24, 2017. The speed started to drop around 3 a.m., hovered around 50 mph from 5 a.m. to 8 a.m., and gradually returned to normal by noon. Meanwhile, the friction conditions exhibited a similar pattern—changed from the worst condition of snow warning/ice watching to the normal situation (wet and trace moisture, then dry). Both the speed and friction sensors appeared to detect the impact to traffic at a similar time. Figure 39 provides camera views of the roadway for Site #1 on the same day. From top left to bottom right, it shows the conditions of snow warning, ice watch, wet, and trace moisture, respectively. The color bordering each camera image can also be related to the friction color shading in Figure 38.

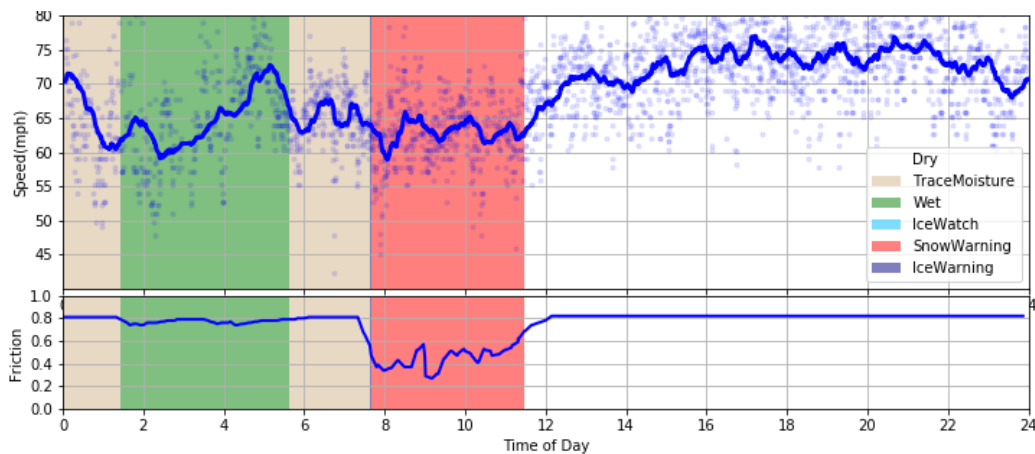
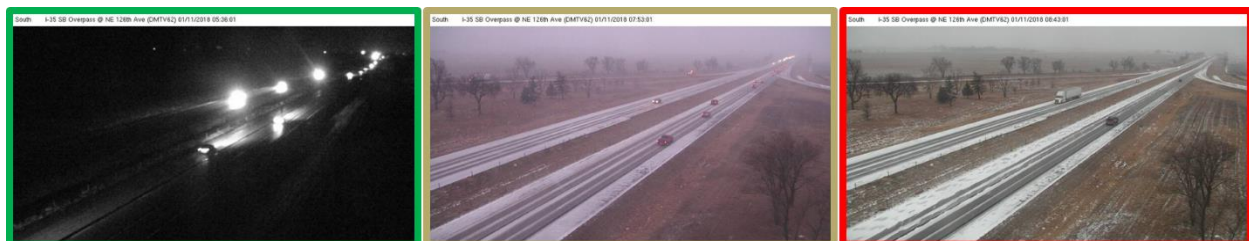
Figure 40 and Figure 41 show the speed profile and roadway surface states for Site #2 on January 11, 2018. Both the speed and surface condition were in the worst situation during the morning, when the speed was about 10 mph slower than the posted speed limit (70 mph), and the sensor was triggered by the snow warning. Once again, at 7:38 a.m., the sensor was sending out the warning of ice for a very short period of time (shown by an extremely thin purple patch).
