# Design and Performance Verification of a Bridge Column/Footing/Pile System for Accelerated Bridge Construction (ABC)

**Final Report**  
**March 2020**

**Sponsored by**  
Iowa Highway Research Board  
(IHRB Project TR-673)  
Iowa Department of Transportation  
(InTrans Project 14-495)

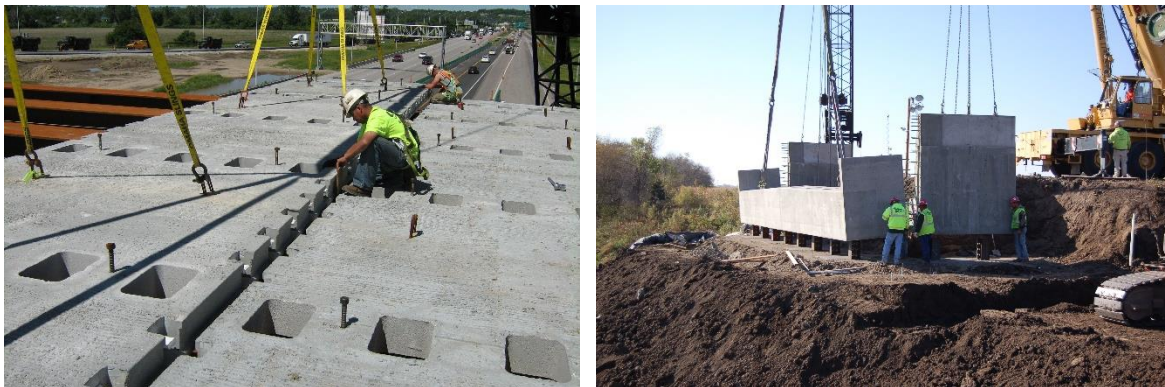
**Figure 1.1. Use of precast elements in Iowa bridge construction**

Precast elements also help to improve bridge quality and durability. Due to the advantages over traditional cast-in-place construction, the use of precast bridge elements has recently become a common practice. Successful practices were found nationwide (ABC-UTC 2018). As shown in Figure 1.1, the Iowa Department of Transportation (DOT) has widely implemented precast elements in bridge construction, ranging from superstructures (e.g., full-depth precast deck panels of the 24th Street Bridge in Council Bluffs and precast box girders of the Madison Bridge) to substructures (e.g., precast abutment footings of the Mackey Bridge in Boone County and precast frame piers of the US 6 Bridge over Keg Creek).

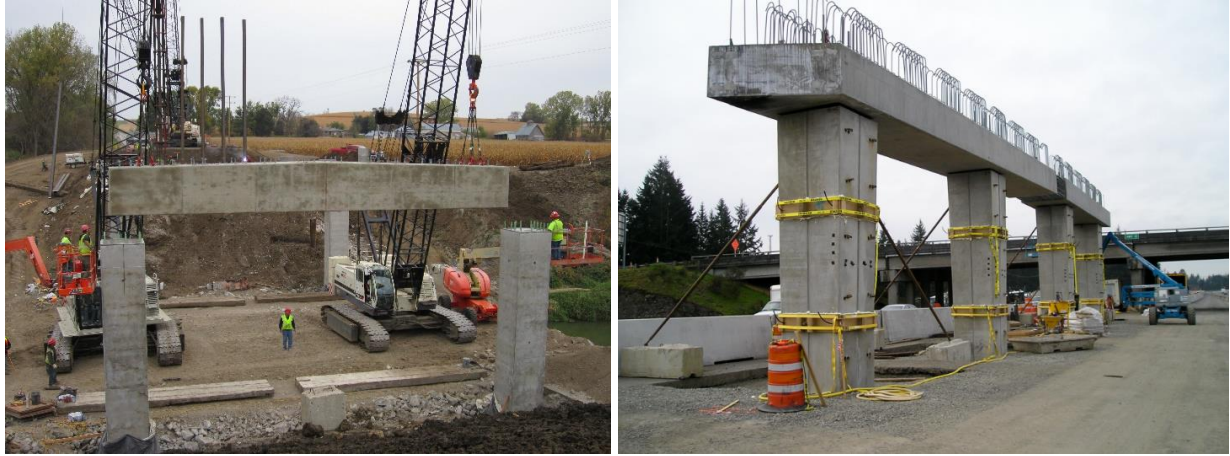
**Figure 2.2. Precast frame piers: US 6 Bridge over Keg Creek (left) and US 12 Bridge over I-5 at Grand Mound (right)**

Due to the difficulty of forming and pouring the bent cap and column at height, construction of a frame pier can be challenging. Using precast elements can eliminate the on-site forming and save significant time during construction. With precast technologies, a typical frame pier can be constructed in as little as two days once the footings are in place (Culmo 2011). Many state agencies have utilized precast elements in the construction of frame piers. The Iowa DOT has successfully accomplished the construction of the US 6 Bridge over Keg Creek with precast columns and precast bent caps (Figure 2.2 left).

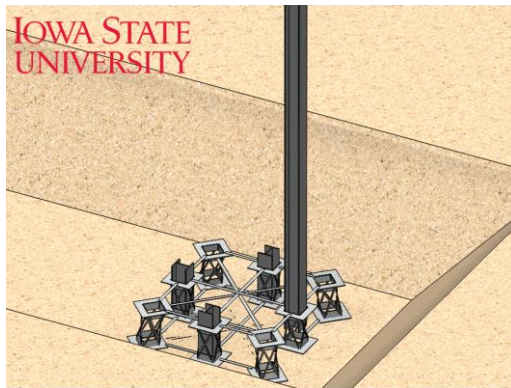
strength of 4,000 psi in 8 hours, and the friction collars were designed to carry the weight of the pile cap, column, and upper structural components before the SCC reaches adequate strength. Therefore, construction of the upper structure can continue the day after completing closure pours. When the SCC reached the specified short-term strength, the friction collars were removed for reuse. The assembly process is illustrated in Figure 3.2.

1. Driven steel pile with a template

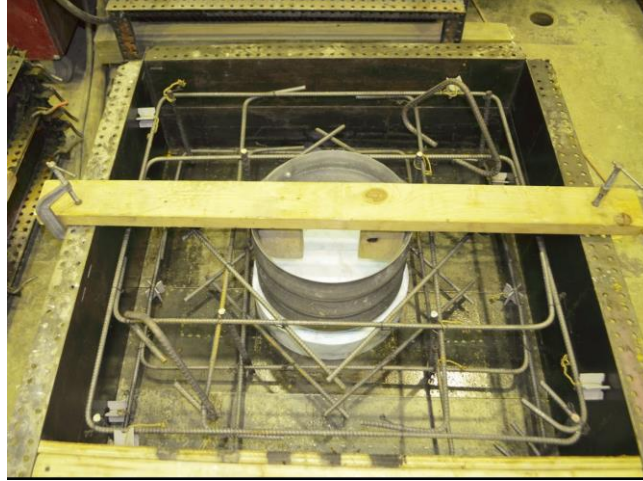
To construct the foundation, a 3 in. thick circular piece of Styrofoam was glued on the base formwork for creating the oversize blockout. After fabricating the reinforcing cage, as shown in Figure 4.3, CSP was placed on the Styrofoam and immobilized by a crossing 2 in. by 4 in. wood beam that was clamped to the formwork side.

**Figure 4.3. Reinforcing cage and CSP installation for foundation**

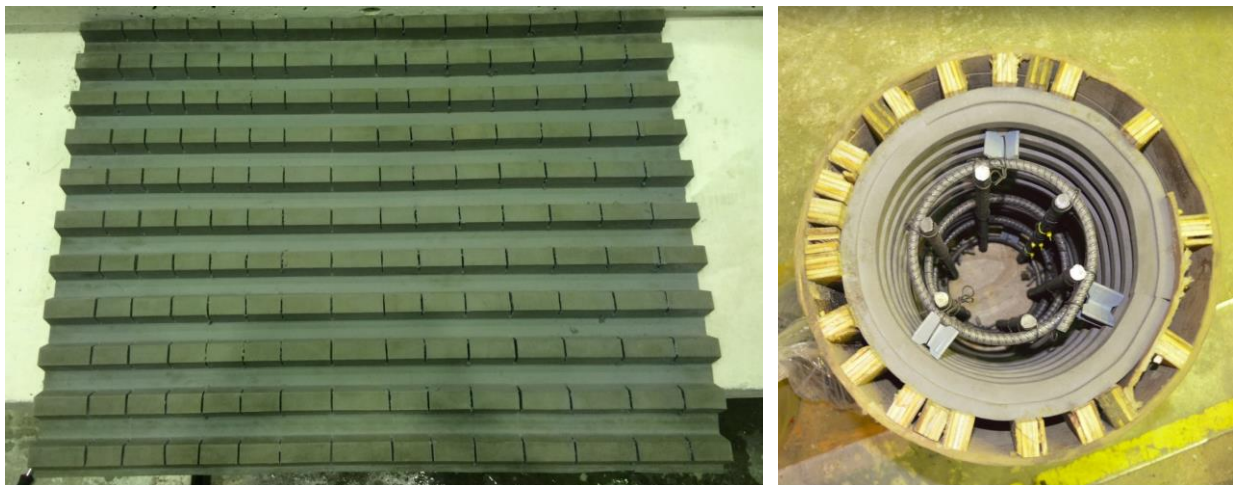
The columns were constructed with different surface roughness. Surface textures with 0.5 in. and 0.75 in. fluted fins were created through the use of a Scott System elastomeric form liner; the exposed aggregate surface was achieved by applying an Altus Series V In-Form Retarder (175) to the concrete tube form; and the smooth surface was made with a no-treatment concrete tube form. As shown in Figure 4.4, a number of breaches were cut on the fins of the form liner to improve its flexibility, such that the form liner could be rolled into a concrete tube form.

**Figure 4.4. Form liner used to create fluted fins on the column**

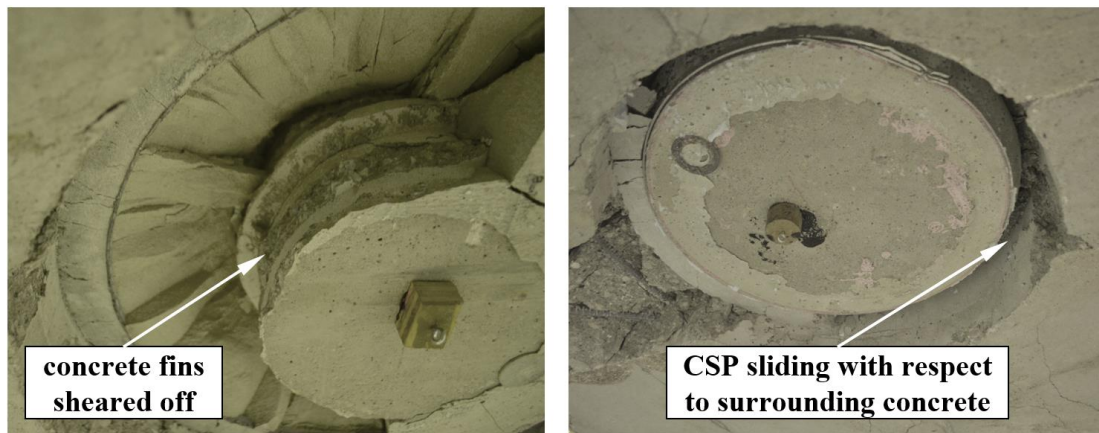
Regardless of the type of loading, the specimens exhibited two failure modes as shown in Figure 4.10.

**Figure 4.10. Failure modes of the specimens**

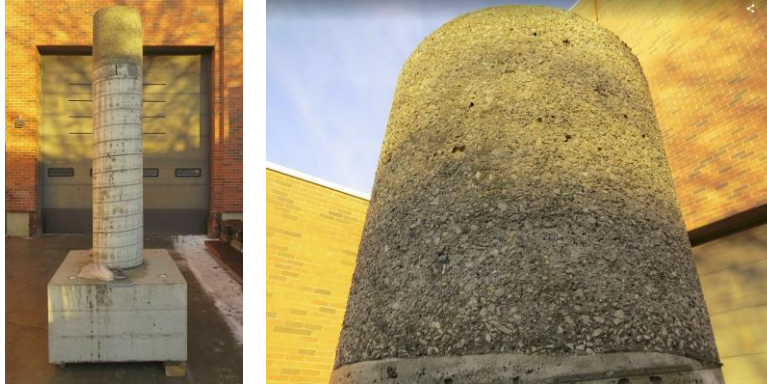
**Figure 5.7. Completed precast column (left) and exposed aggregate finish (right)**

The tube form was removed three days after placing concrete. The exposed aggregate surface at the column end was finished by power washing. Figure 5.7 shows the completed precast column with a close view of the exposed aggregate surface.

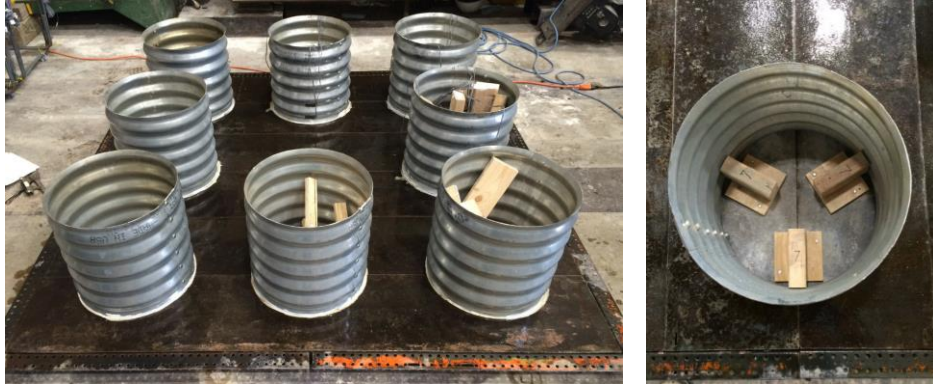
For construction of the pile cap, eight 15 in. long, 15 in. diameter CSPs were first positioned on the base formwork. Each CSP was immobilized by three wood locks that were screwed on the base formwork, as shown in Figure 5.9.

**Figure 5.9. CSPs and wood locks**

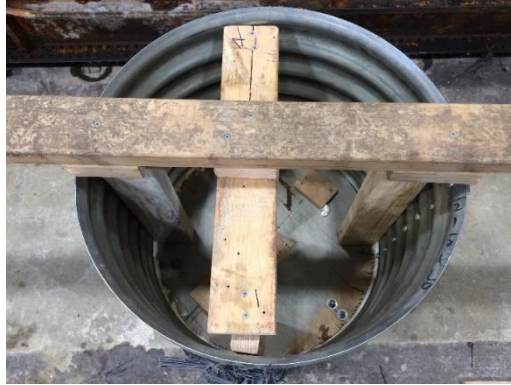
Three reusable reducers with shrunk diameter were placed inside the pile CSPs and temporarily supported by 2 in. × 4 in. wood beams, as shown in Figure 5.10 center and Figure 5.10 right. The gaps between the CSPs and the reducers were sealed using GREAT STUFF Gaps & Cracks foam sealant. After fabricating the reinforcing bars beside the reducers, the side formworks were assembled. A 1 ft 8 in. long, 21 in. diameter CSP for creating the column socket was hanged on the crossing beam that was clamped on the side formwork. The bottom of the CSP was closed by a round plywood with a size slightly less than the inside diameter of the CSP, as shown in Figure 5.11, such that the plywood could be taken out through the CSP.

**Figure 5.11. Plywood for closing the CSP with CSP hanger**

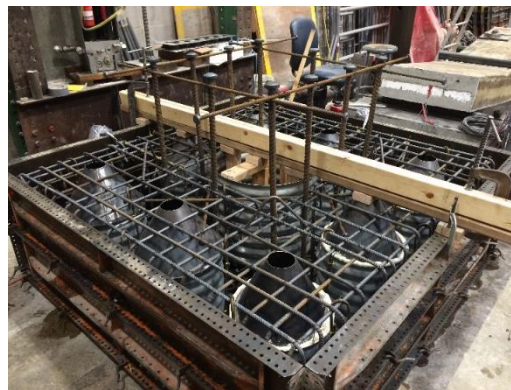
Ten #8 headed bars were vertically tied on the pile cap reinforcing cage, as shown in Figure 5.12.

**Figure 5.12. Pile cap before concrete pour**

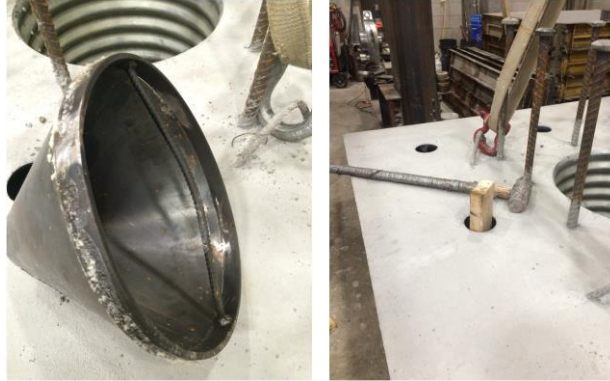
These bars were extended 1 ft 9 in. above the top of the side formwork for constructing the loading block that would be used for testing the pile foundation. The crossing beam and the plywood for closing the CSP were removed after the concrete was set. The reusable reducers were taken out when the pile cap was lifted off the ground with a crane. A reinforcing steel bar was welded across the diameter of the reducer (Figure 5.13), and then by hammering the reinforcing bar, the reusable reducers were easily taken out through the pile CSP.

**Figure 5.13. Taking out reusable reducers**

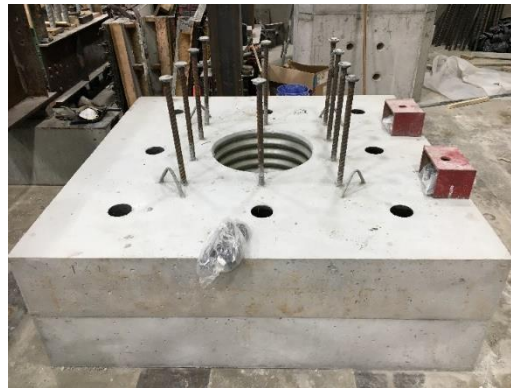
**Figure 5.14. Completed precast pile cap**

Figure 5.14 shows the completed pile cap.

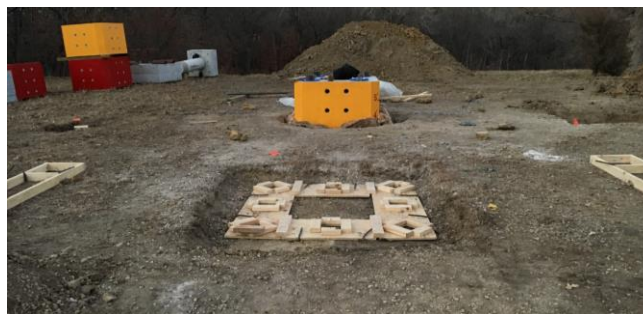
**Figure 5.15. Driven pile template**

A foot of soil at the testing site was excavated to remove the top layer that was composed of gravel and cobble. To maintain the piles in the proper position and alignment, a plywood template was nailed on the ground using a bent reinforcing steel bar, as shown in Figure 5.15.

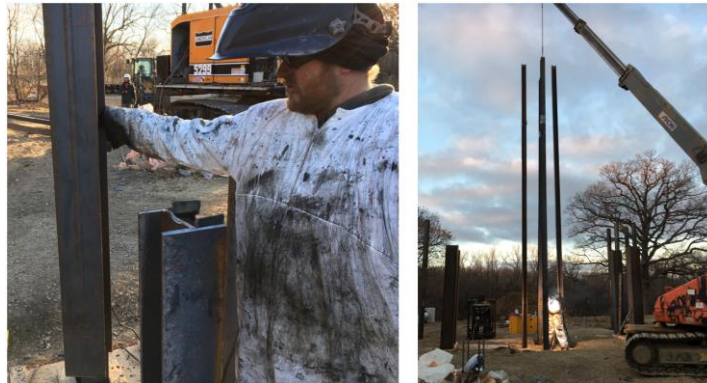
**Figure 5.16. Weld-splicing piles**

The contractor used a swinging lead with a Delmag D12-42 diesel pile hammer for the pile driving job. To avoid buckling the W 6×20 sections, the pile foundation was constructed by

splicing two short pile sections together. The 31 ft long pile sections were driven first, and the top foot was cut if driving damage appeared on the top of piles. Since no damage eventually occurred, the contractor decided to leave the top foot. After the 29 ft long sections were weld-spliced to the 31 ft long sections by an Iowa DOT-certified welder, as shown in Figure 5.16, the piles were driven 51 ft deep such that the preinstalled instrumentation would be located at the specified depth.

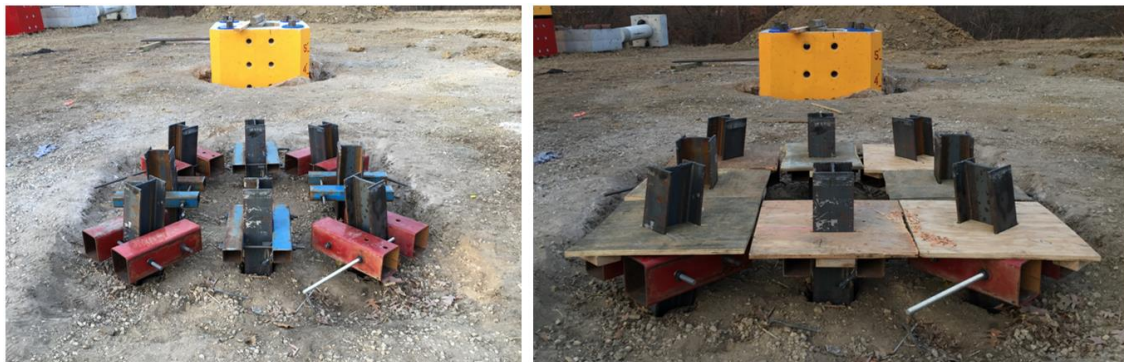
**Figure 5.17. Friction collars and plywood seal-pads**

The extra length was cut off, and all piles were trimmed to a horizontal line above the ground. After driving the piles, friction collars were installed on each pile as shown in Figure 5.17.

The position of each friction collar was adjusted to levelly support the pile cap. Plywood seal-pads with voids that fit the outline of the piles were placed on the friction collars for sealing the pile sockets. To facilitate removal, the seal-pads were made of two pieces and screwed together.

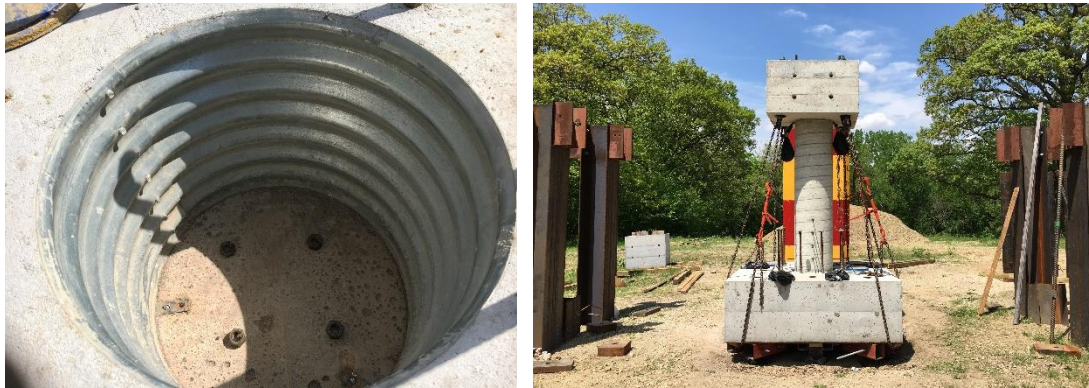
**Figure 5.18. Nut shimmers underneath column (left) and temporary column bracing (right)**

After cleaning surface laitance in the column socket, the precast column was erected on the pile cap. Four stainless steel nuts, as shown in Figure 5.18, were placed in the socket to shim the column and to create a grout pad underneath the column.

The column was temporarily braced with chains, and the column plumb was achieved by adjusting the attached ratcheting binders, as shown in Figure 5.18.

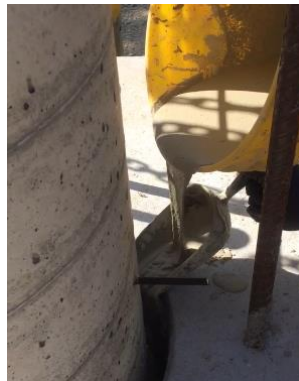
**Figure 5.19. Grout pouring**

The column socket and the pile sockets were then filled with Rapid Set ULTRAFLOW 4000/8 grout and SCC, respectively, to complete the test unit construction. The grout was poured at one spot and allowed to flow around the column to prevent air void in the grout closure pour, as shown in Figure 5.19.

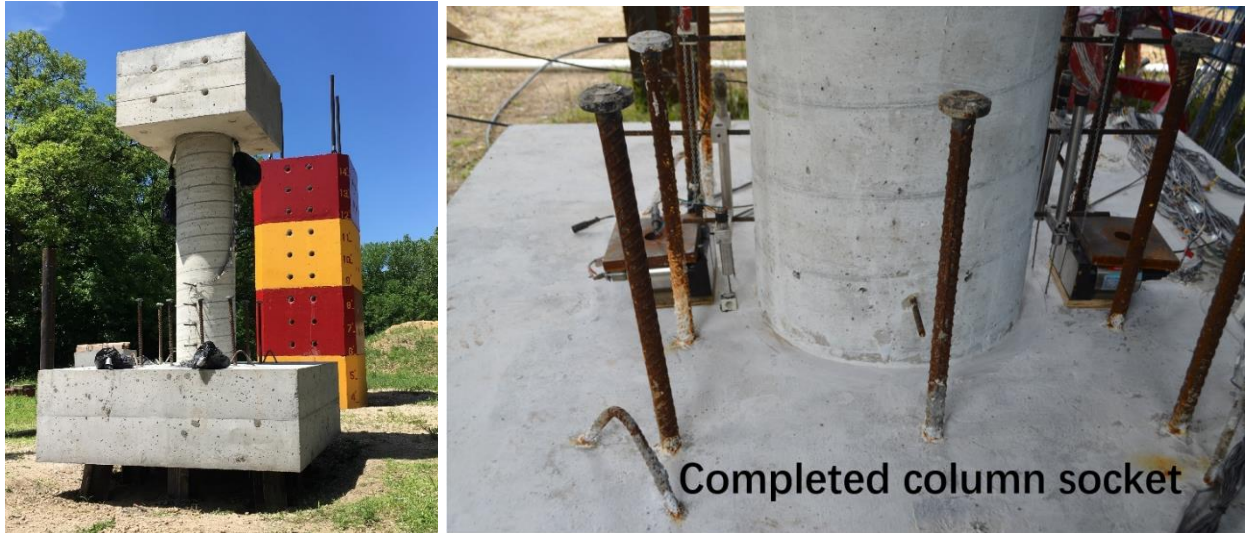
**Figure 5.20. Completed test unit**

As the product datasheet suggested, the grout was immediately covered with a wet rag and tarp after pouring to avoid shrinkage cracking. The column bracing was removed 10 hours after the grout pour when the grout compressive strength reached 5,231 psi. After the SCC in the pile sockets reached a compressive strength of 4,614 psi 7 days after the concrete pour, the friction collars were taken off. The completed test unit is shown in Figure 5.20.

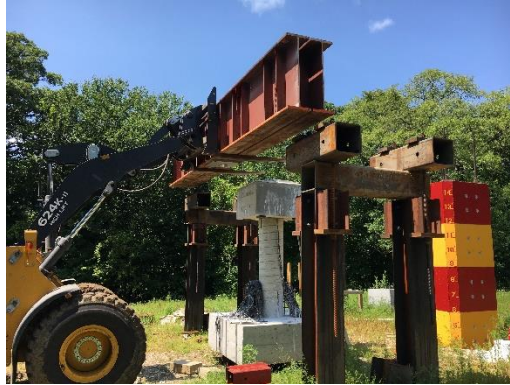
**Figure 5.22. Placing main reaction beam**

The anchor piles were driven 50 ft deep below ground surface with 9 ft 3 in. left above the ground. The attachments were then bolted on the anchor piles, followed by placement of the main reaction beam (Figure 5.22).

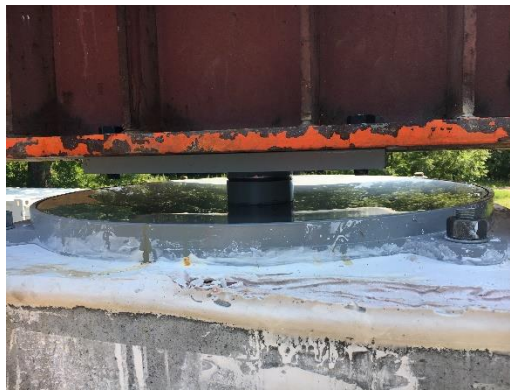
**Figure 5.23. Single friction pendulum isolator between column and reaction beam**

As shown in Figure 5.23, a friction pendulum bearing was installed between the top of the column loading block and the main reaction beam.

This bearing was used to transfer the vertical loads from the main reaction beam to the column with minimal friction against the lateral load, while allowing translation and rotation of the column. The hydraulic cylinders pushed the main reaction beam down as they were pressured, thereby generating gravity effects on the column while subjecting the anchor piles to tension.

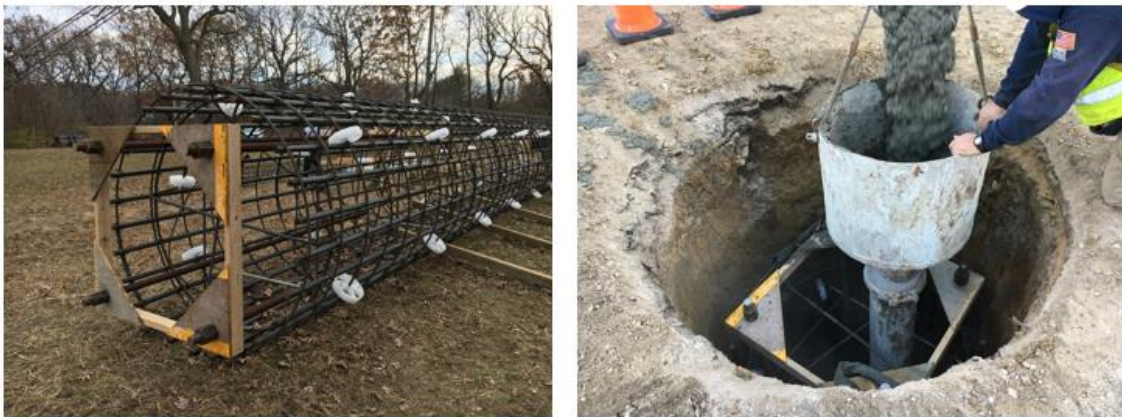
**Figure 5.27. Construction of drilled shaft**

The top of the shaft was 4 ft below the ground for easy demolition after testing. The reinforcing cage, as shown in Figure 5.27 was tied horizontally on temporary supports and then lifted to the vertical for placing in the borehole.

Four anchor rods were tied on the cage for embedding into the shaft. To avoid forming a weak section, two rods were embedded 11 ft and the other two were embedded 13 ft into the shaft. The top foot of the anchor rods was debonded using duct tape to prevent unexpected cracking at the top of the shaft. A template was installed on the extended portion of the anchor rods to properly position them prior to and during concrete placement. Concrete was placed by the free-fall method, directing the flow into the center of the shaft. After the concrete set, a layer of hydrostone was poured on top of the shaft. The base segment of the reaction column was set in

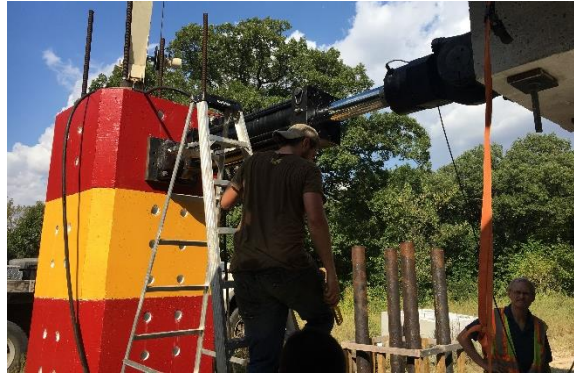
**Figure 5.28. Lateral actuator attached on reaction column**

place prior to hardening of the hydrostone to ensure the desired contact. The post-tensioned rods were connected to the anchor rods using rod couplers. Following the erection of all precast column segments, construction of the lateral reaction column was finished by post-tensioning the rods to the specified force of 200 kips. As shown in Figure 5.28, a hydraulic actuator controlled by an electric servo pump was laterally attached to the reaction column to apply lateral force on the test unit.

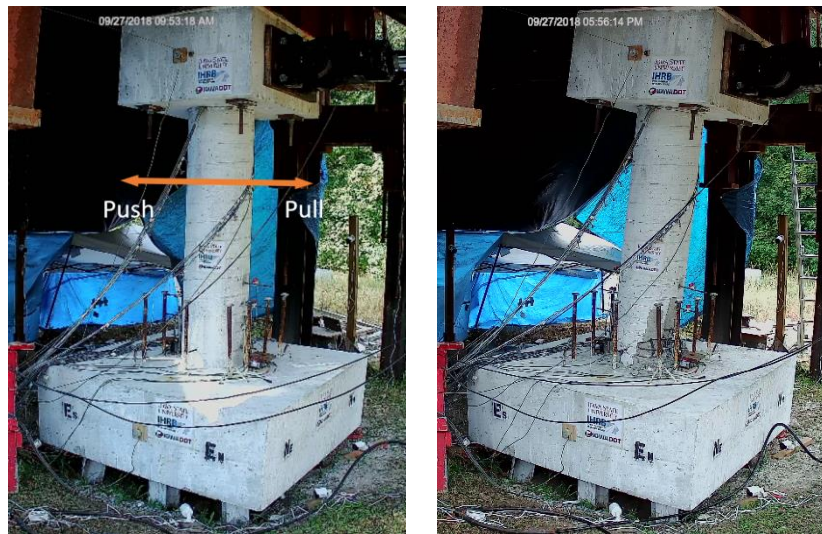
**Figure 5.40. Column drift at the end of Phase I (left) and Phase II (right)**

In Phase I, no cracking or any other damage was observed on column. Due to about 0.75 in. eccentricity of the vertical load resulting from construction tolerance, the column displaced toward the push direction with increase in vertical loads. However, under the full vertical load of 250 kips, the lateral displacement of the column at the height of the horizontal actuator, hereafter referred to as the column top displacement, was negligible. Under the cyclic lateral loads of Phase I, the column top displacement did not exceed 0.48 in. (Figure 5.40 left).

During Phase II, the column experienced displacement up to 7.5 in. at the height of the horizontal actuator, as shown on the right in Figure 5.40. The primary damage occurred at the base of the column as intended. Flexural cracks began to develop at the column base when the applied lateral loads reached 25.2 kips. Cracking continued to develop over the lower 36 in. of the column as testing progressed and the column lateral displacement was progressively

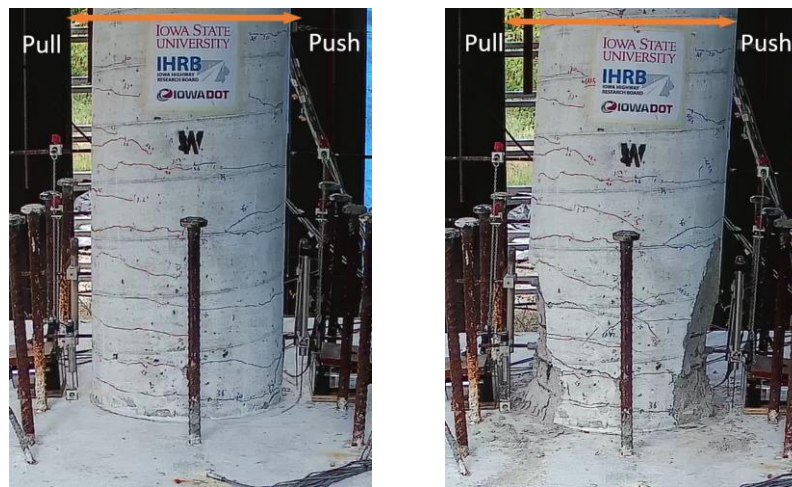
**Figure 5.41. Damage at the column base: flexural cracks (left) and cover concrete spalling (right)**

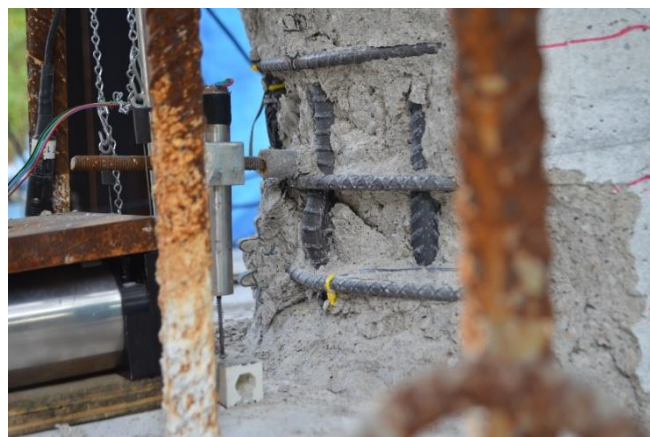
**Figure 5.42. Buckling of longitudinal reinforcing bar**

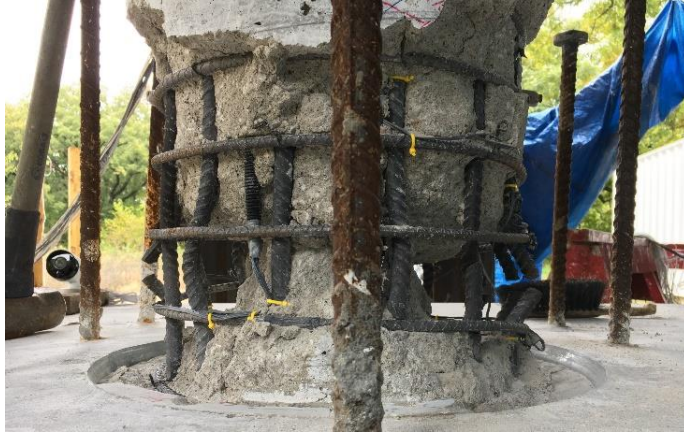
**Figure 5.43. Column base at the end of Phase II**

When the column top displacement was first increased to 7.5 in., the longitudinal reinforcement that buckled in previous load step fractured in tension. As the column cycled at the displacement of 7.5 in., multiple column longitudinal reinforcements fractured, and a significant part of the core concrete was crushed. The damage on the column base at the end of Phase II was shown in Figure 5.43.

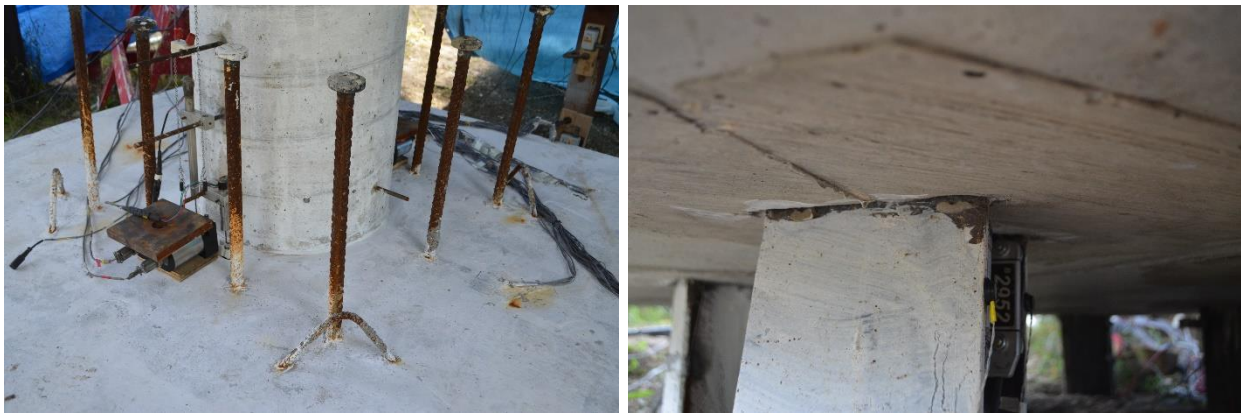
**Figure 5.44. No damage on column connection (left) and pile connection at the end of Phase I, (right)**

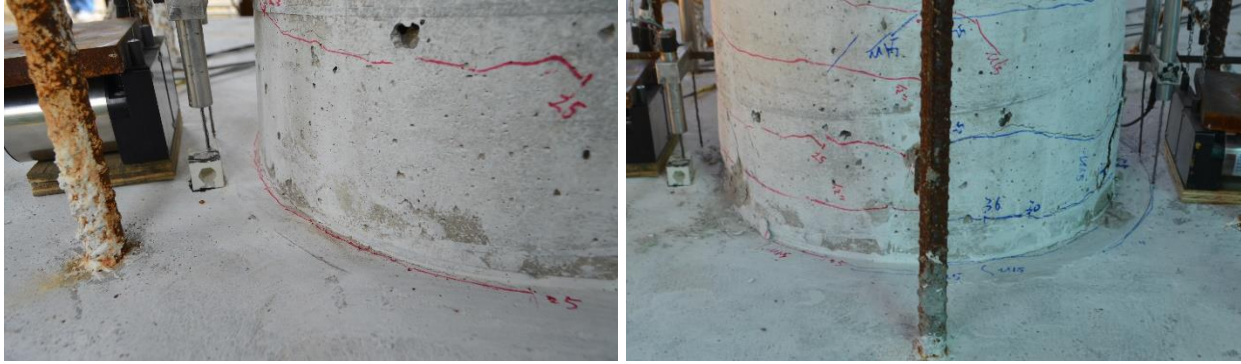
**Figure 5.45. Crack at column-to-grout pour interface**

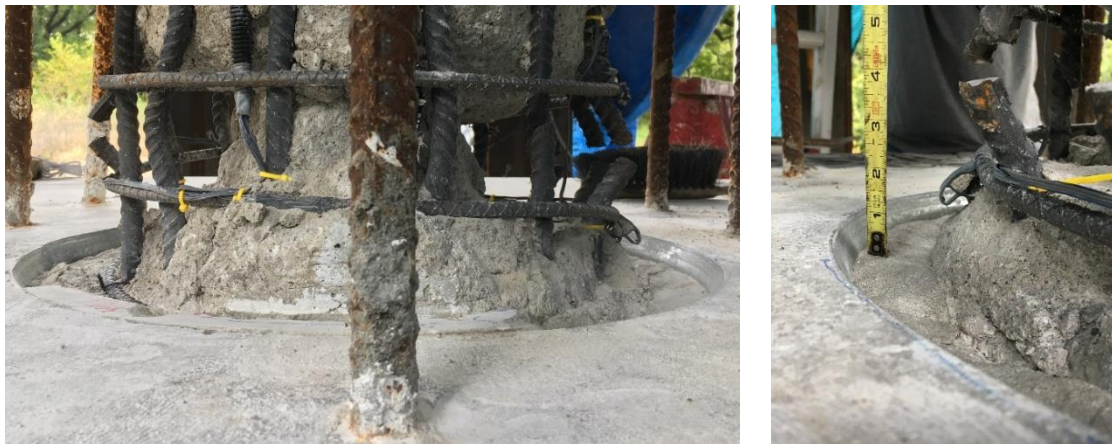
**Figure 5.46. Spalling of grout closure pour at the end of Phase II**
