# Automated Assessment of Defects in Bridge Structures

**Final Report**  
**April 2025**

**Sponsored by**  
Iowa Department of Transportation  
and Federal Highway Administration  
(SPR-RE-222(014)-8H-00,  
InTrans Project 22-798)

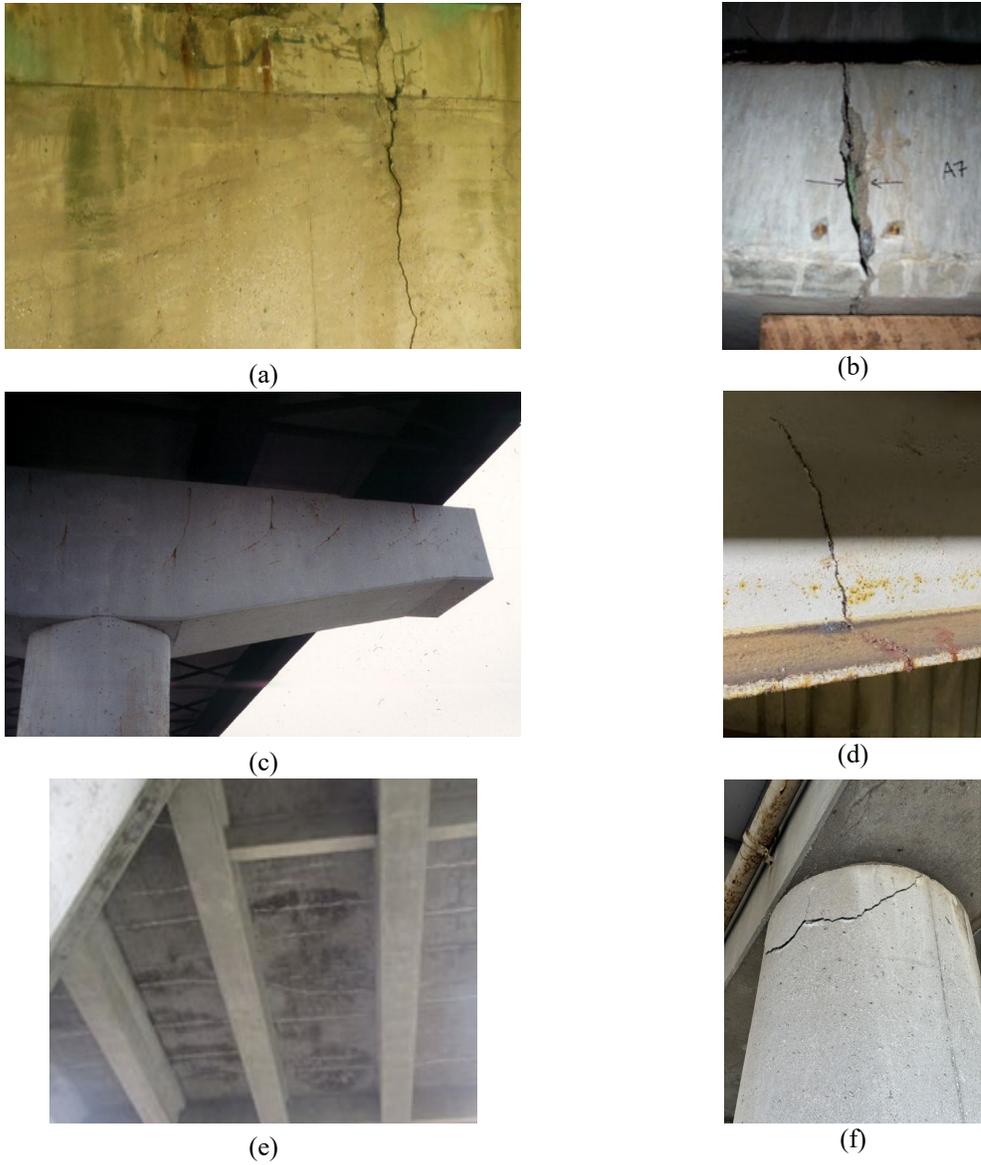
**Figure 2.1. Examples of cracks in bridge components: (a) abutment, (b) concrete girder, (c) pier, (d) steel girder, (e) deck, and (f) column**

The structural integrity of bridges is crucial for ensuring public safety and infrastructure longevity. Figure 2.1 depicts the prevalence of cracks in bridge components.

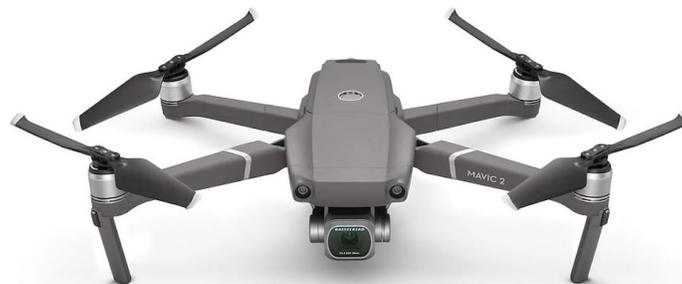
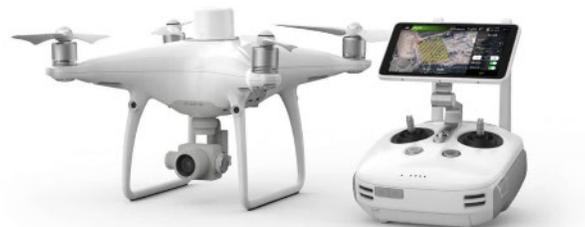
Two types of drones were used to collect the image datasets used in this study, DJI Mavic 2 Pro and DJI Phantom 4 RTK (Figure 3.1)

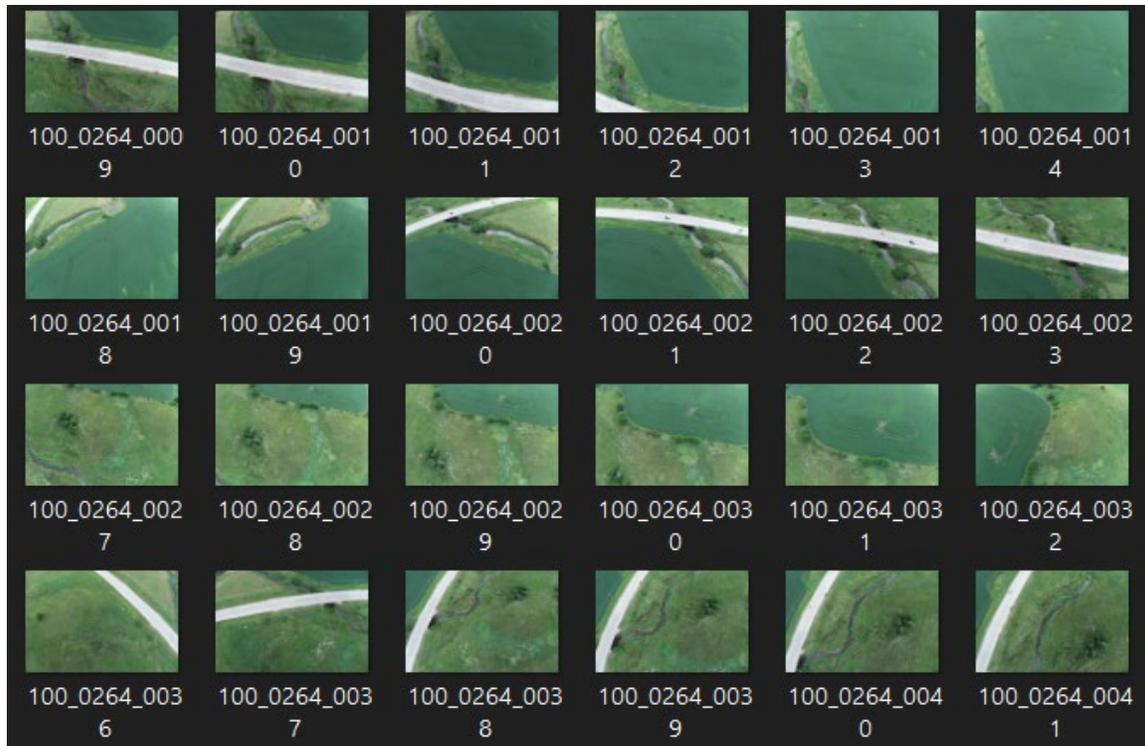
**Figure 3.4. Example of the dataset from the Phantom 4 RTK drone**

The first dataset consisted of 177 images received from the Mavic 2 Pro drone and 111 images received from the Phantom 4 RTK drone. The quality for both datasets was  $5,472 \times 3,648$  pixels. Figures 3.2 and 3.3 present an example from the Mavic 2 Pro, while Figures 3.4 and 3.5 present an example from the Phantom 4 RTK. The Mavic 2 Pro drone flew at a distance of 50 ft from the bridge, while the Phantom 4 RTK drone covered the area from a distance of about 180 ft.

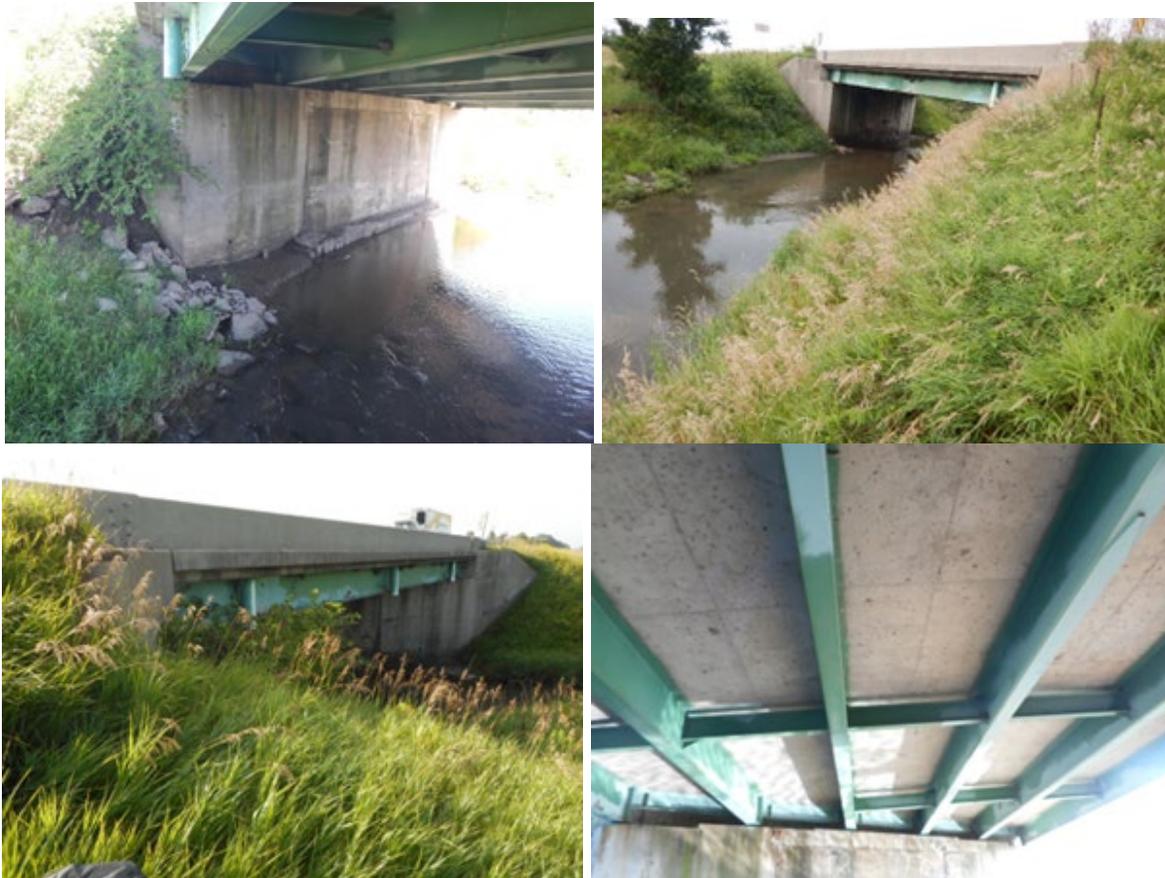
**Figure 3.6. Captured images of the case study bridge**

A bridge characterized by its unique construction and current condition was examined. The bridge, built in 1922, is located 19 miles south of Ames, Iowa. It features a robust design with steel beams supported by high concrete abutments and topped with an RC deck. Spanning 63 ft in length and 44 ft in width, this bridge has been an integral part of the region's infrastructure for 101 years. Despite its age, it maintains a condition rating of fair. In 2021, it was reported to handle an average daily traffic of 6,800 vehicles. However, the bridge shows signs of wear and

tear typical of its age and usage, including cracks in its structure, concrete spalling, rusting of steel components, and peeling paint. Figure 3.6 presents images of the bridge examined in this case study.

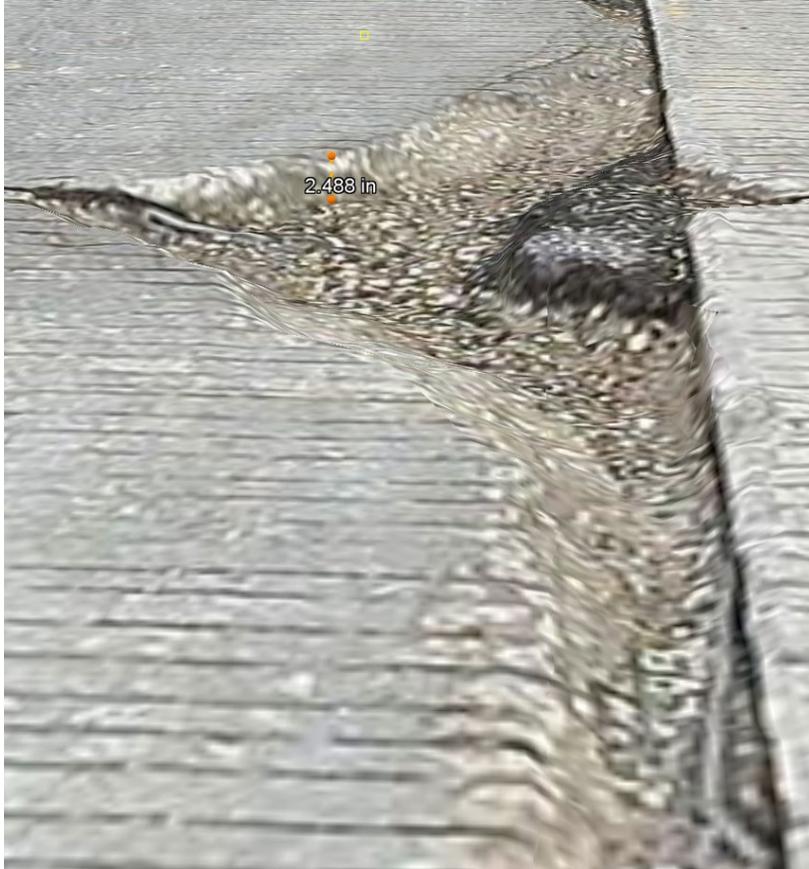
**Figure 3.8. Measurement of the depth of a pothole**

Bentley iTwin Capture has powerful measurement capabilities for characteristics such as location, distance, area, and volume. Incorporating and utilizing these capabilities with high-quality 3D models allows for a safe and fast inspection and damage detection process. In order to represent the use of these measurement tools in Bentley iTwin Capture, some defects were measured in the generated bridge. Figures 3.8 to 3.11 present examples of the use of measurement tools in Bentley iTwin Capture.

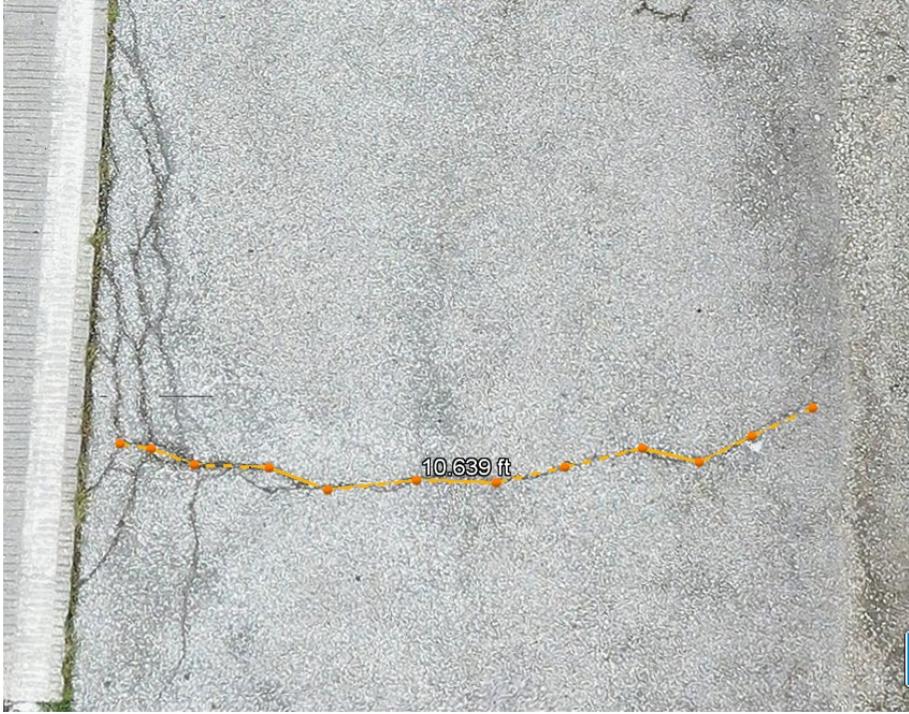
**Figure 3.9. Measurement of the length of a crack**

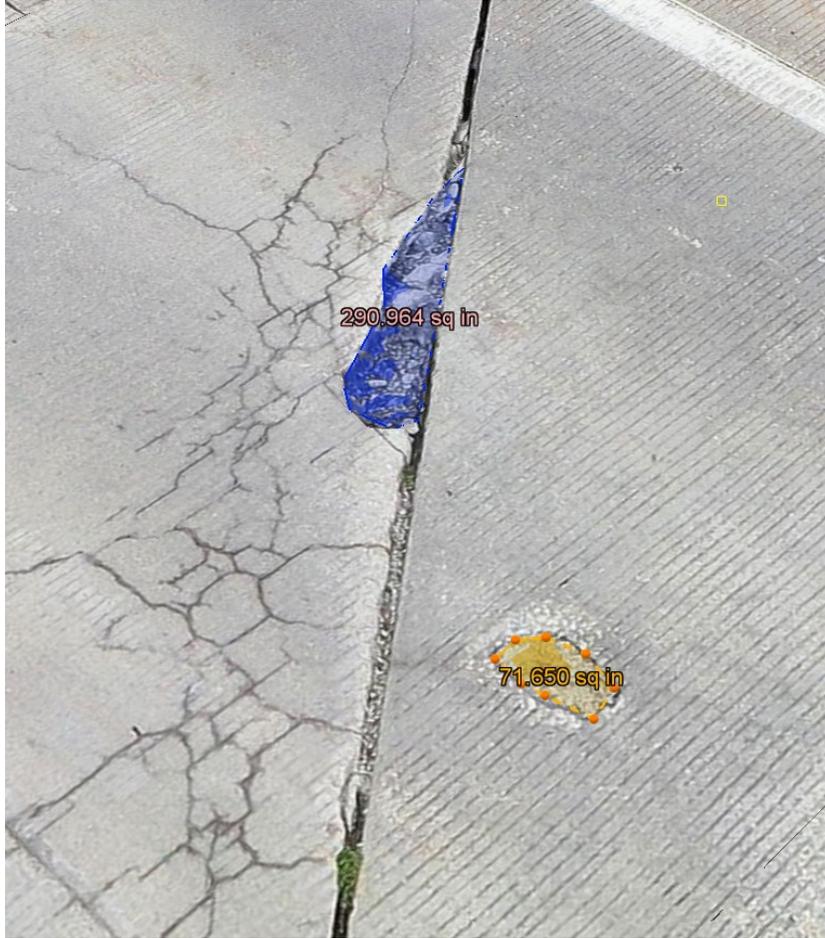
**Figure 3.10. Measurement of the area of a defect**

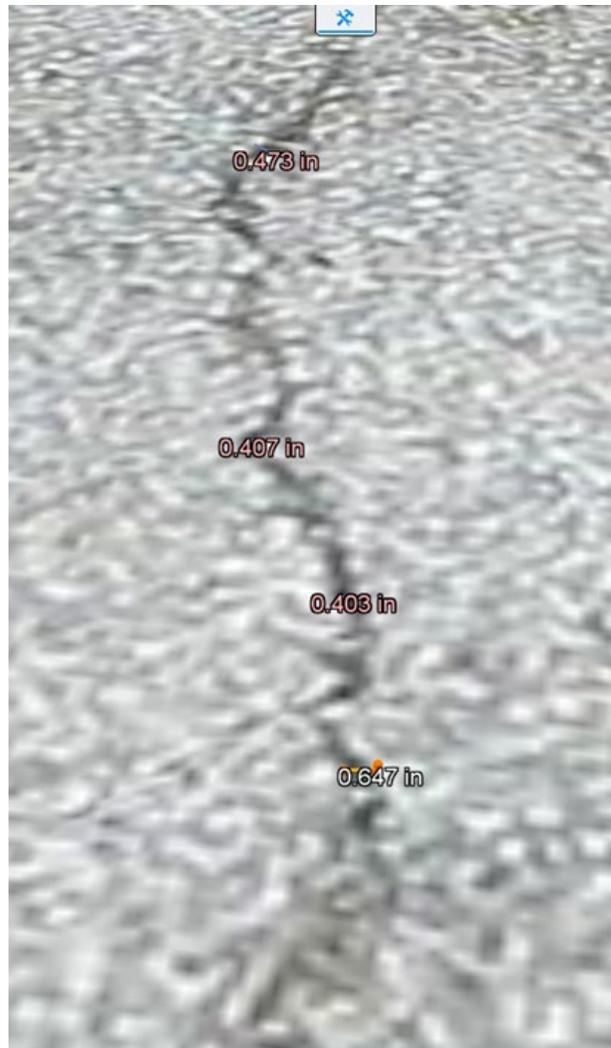
**Figure 3.11. Measurement of the width of a crack**

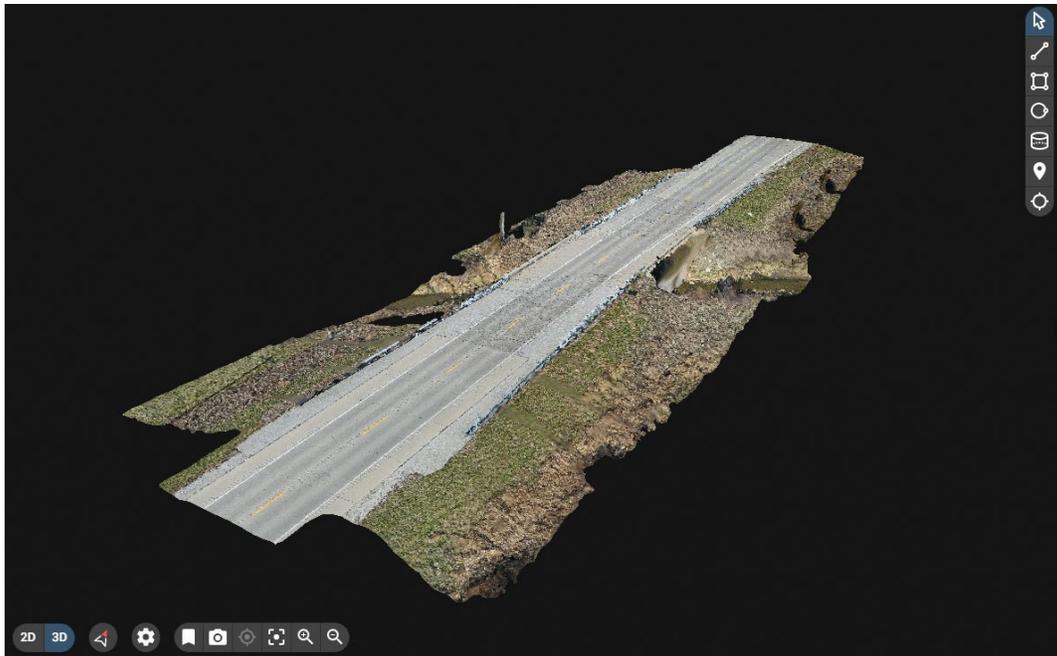
**Figure 3.13. 3D model generated by Pix4D**

The third software application utilized to generate a 3D model was Pix4D. The model generated by this software had the lowest quality of all the models generated for the case study. The details of the defects almost vanished, and the model looked like a pixel model. Figure 3.13 presents the model generated by Pix4D.

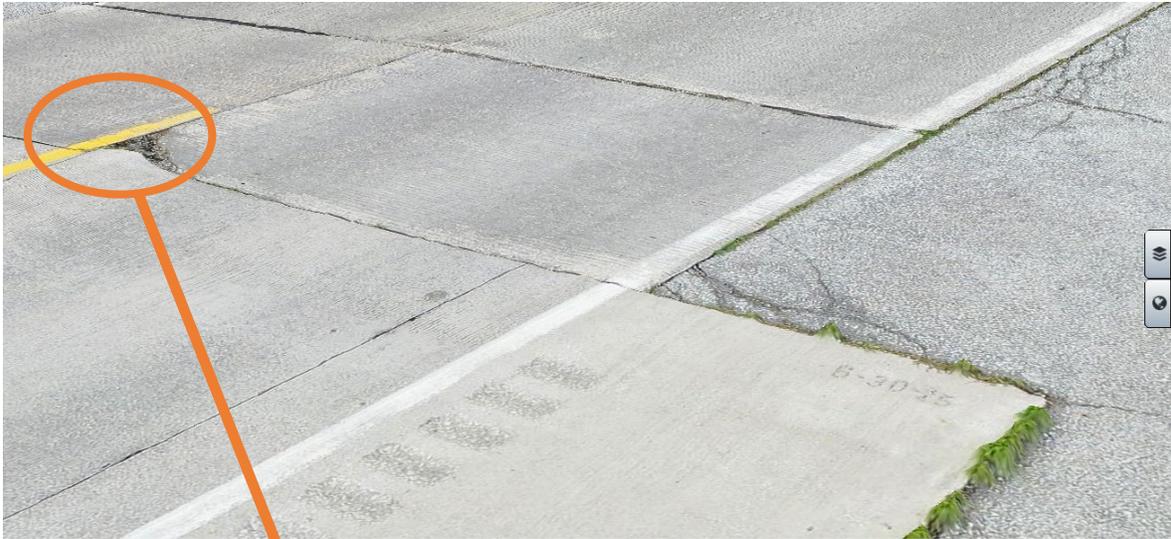
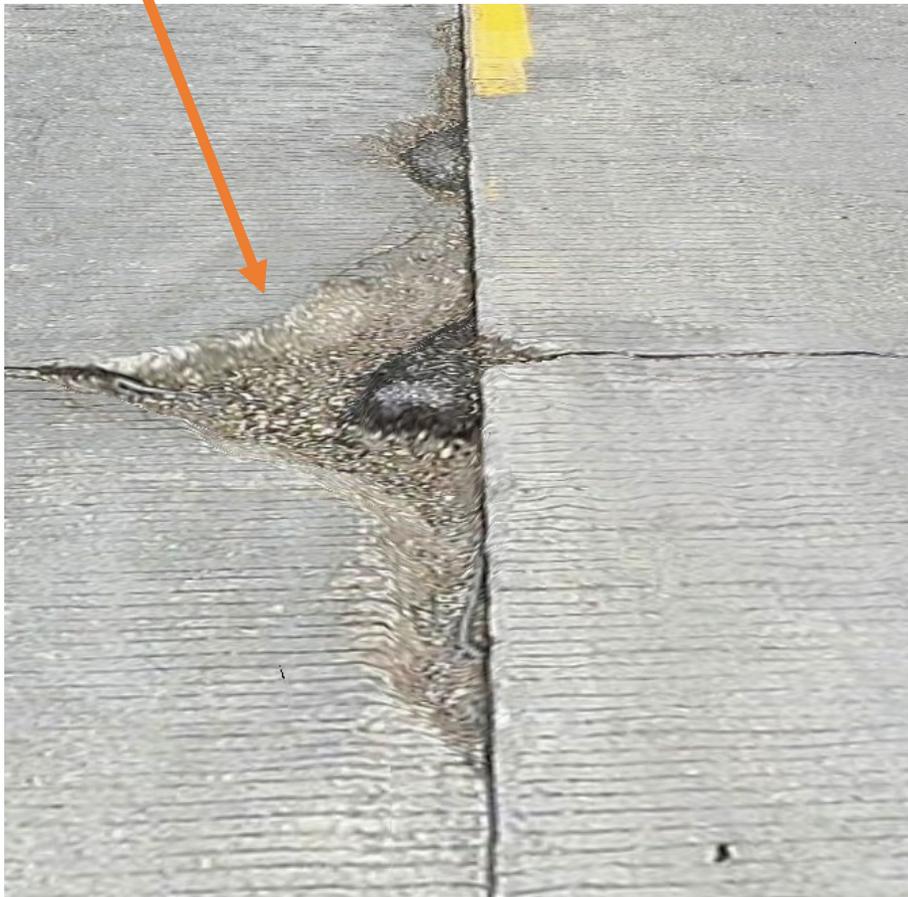
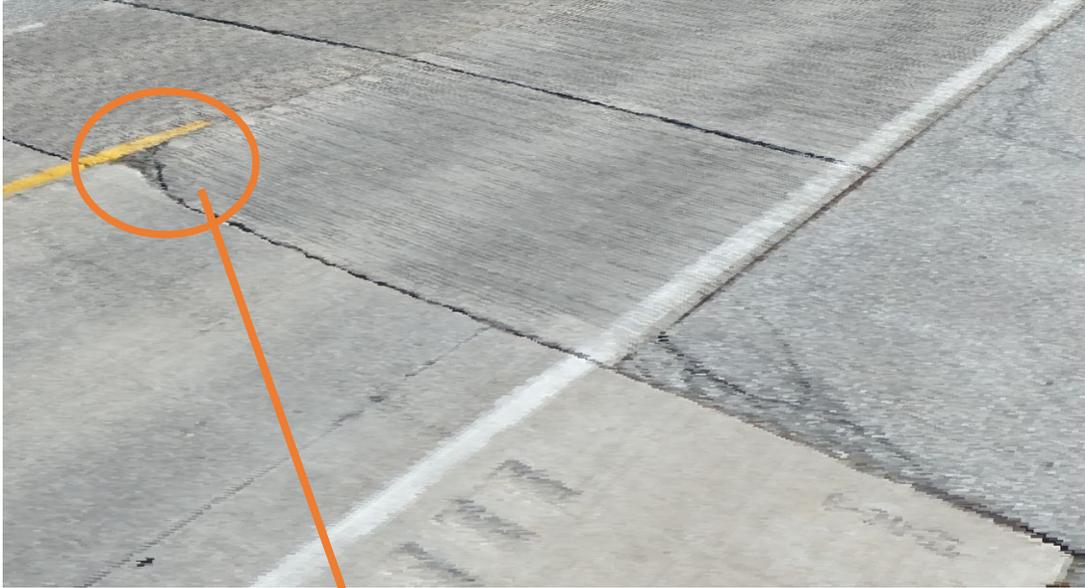
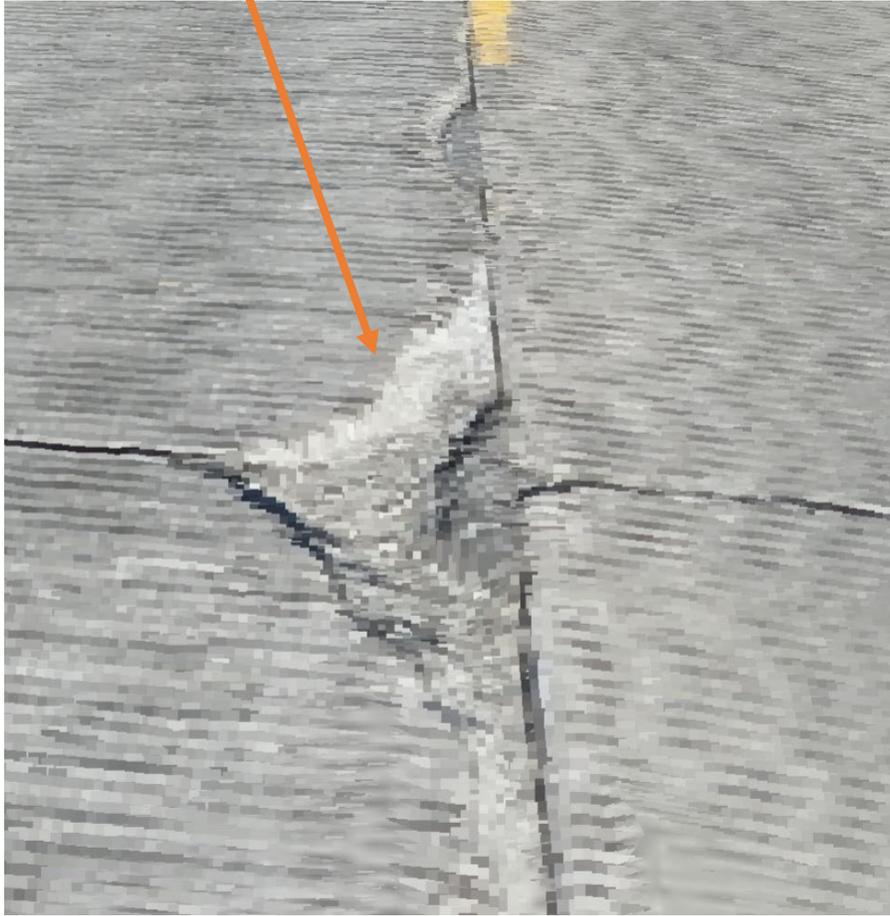
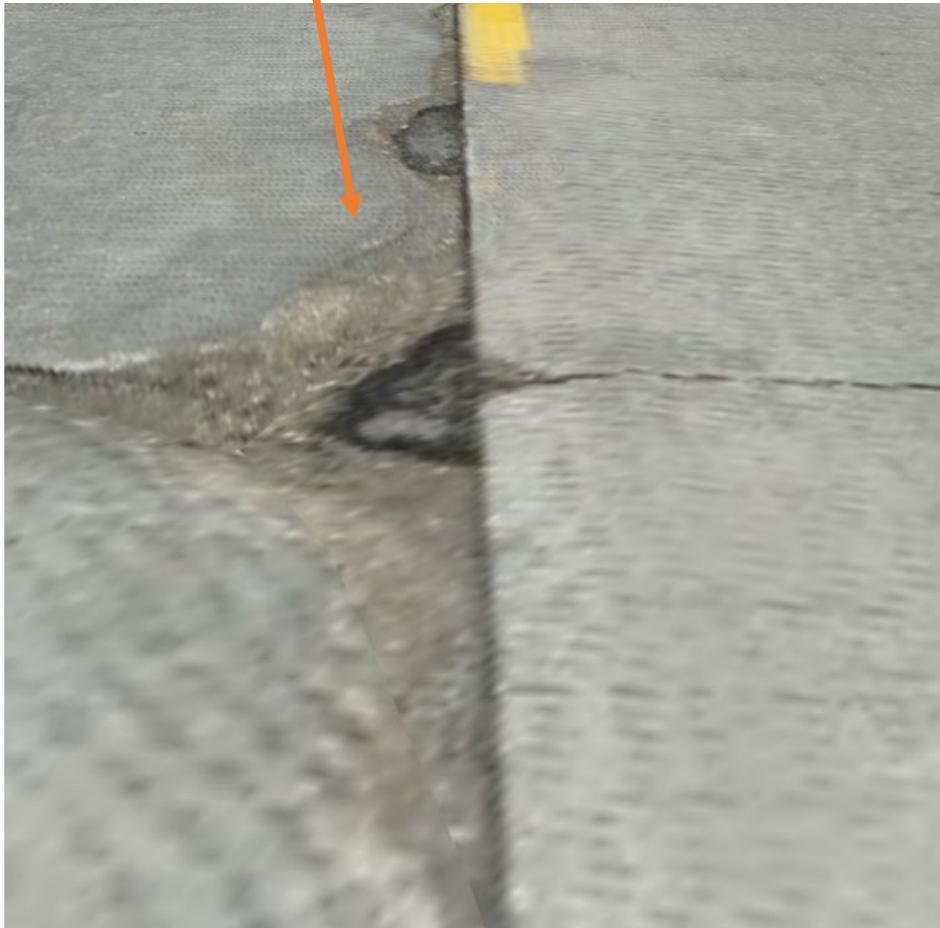
Figure 3.14 shows a comparison between the 3D models generated by the three software applications for the case study bridge. From Figure 3.14, we can notice the difference in model quality between the three software applications, even though all three used the same dataset to generate their models. Bentley iTwin Capture generated the highest-quality and most accurate model among the three software applications.

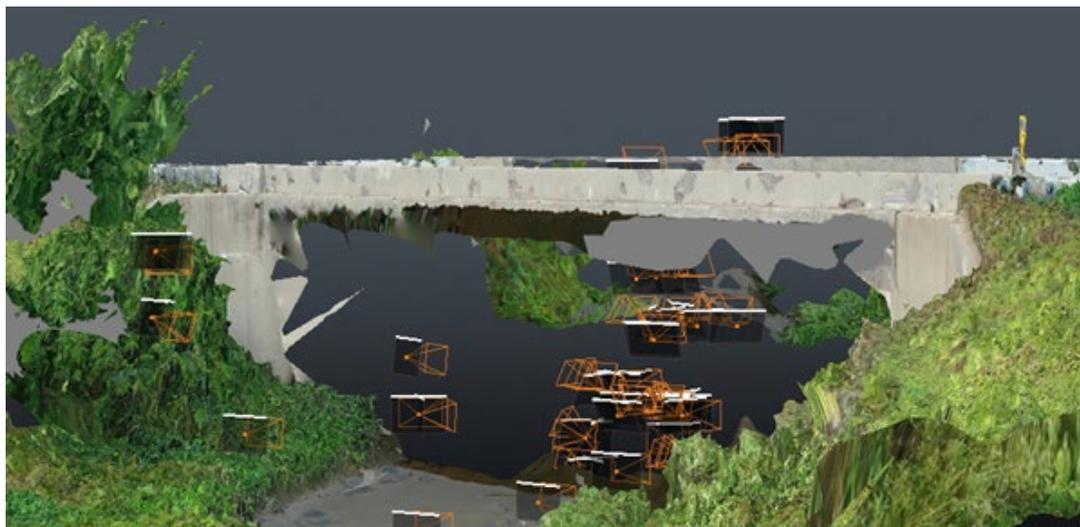
**Figure 3.16. Image locations and positions not used to generate the 3D model**

was attributed to the flying mode of the drones used to capture the image dataset. As mentioned previously, there are several flying modes available for drones. The sequence of the yellow boxes in Figure 3.15 represents the drones flying under automatic mode. In contrast, Figure 3.16 represents the substructure of the bridge, with the orange boxes indicating the images that were not used to generate the 3D model. This occurred because the images in the orange boxes were taken under manual flying mode, where no sequence or overlap between the images was present.

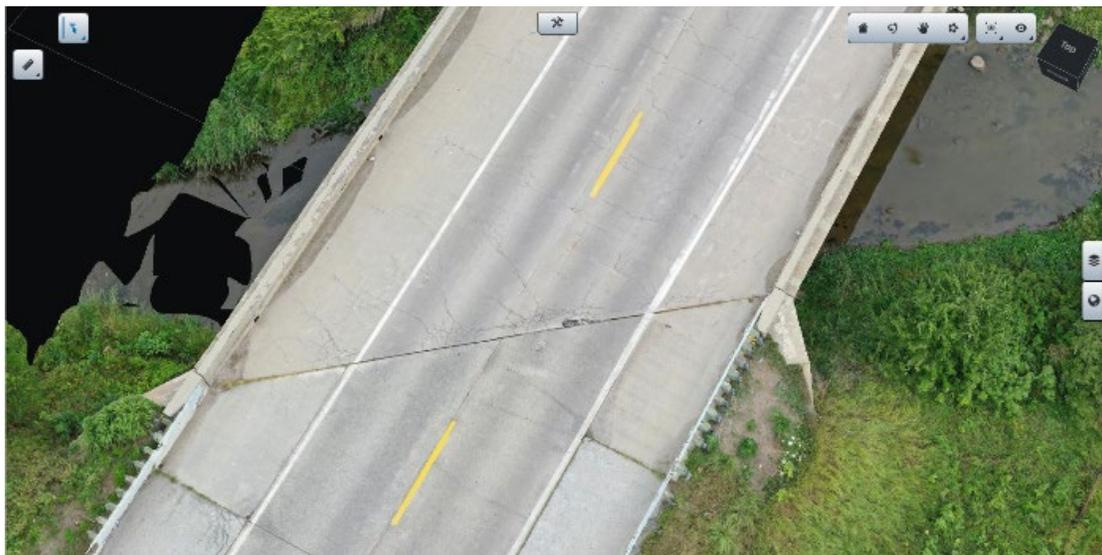
**Figure 3.17. 3D model of the bridge before applying the detection algorithm**

The integration of AI technology into Bentley iTwin Capture represents a significant advancement in the field of infrastructure management. By preparing and training AI algorithms, software packages like Bentley iTwin Capture can automate and enhance various aspects of their operations. AI can be utilized for more efficient and accurate feature recognition in captured data, improving the identification of defects and anomalies during inspections. In this study, we applied AI capabilities to detect potholes and cracks in the case study bridge following the steps outlined in the iTwin Context Capture manual. Figures 3.17 and 3.18 illustrate the before and after results of applying the detection model. The software learns from provided pretrained weights to detect cracks (represented by blue lines) and potholes (indicated by green shadows).

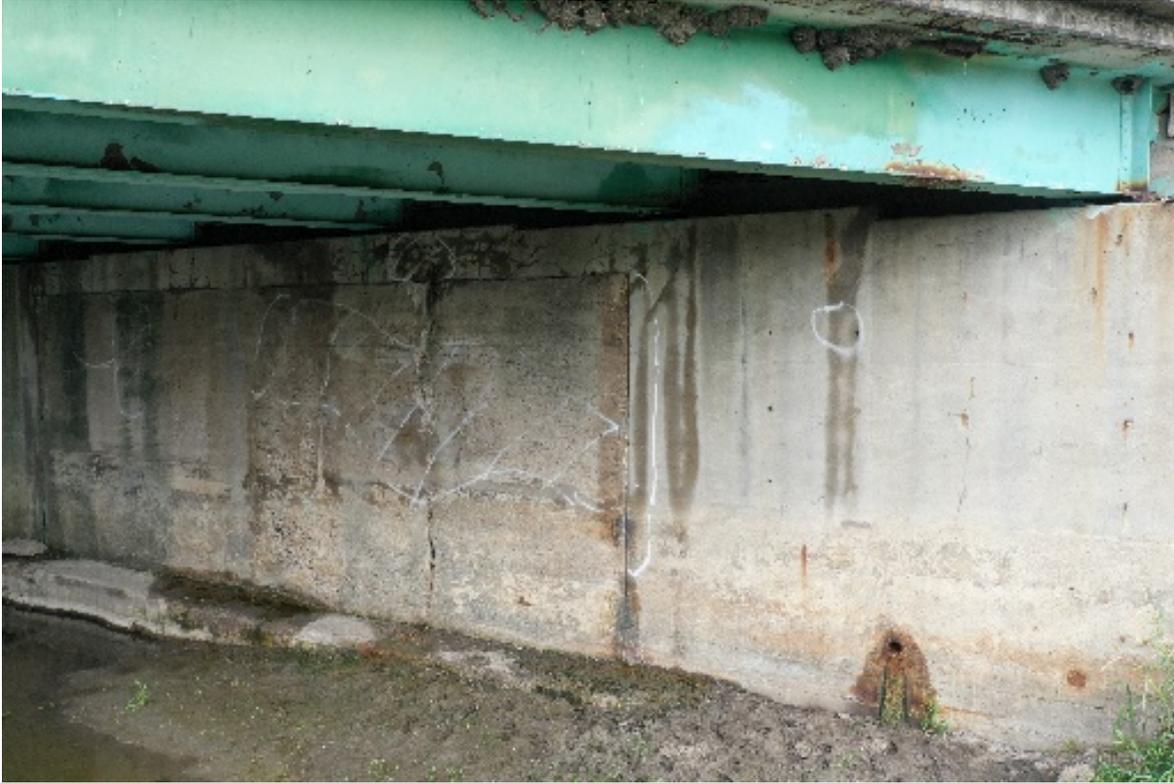
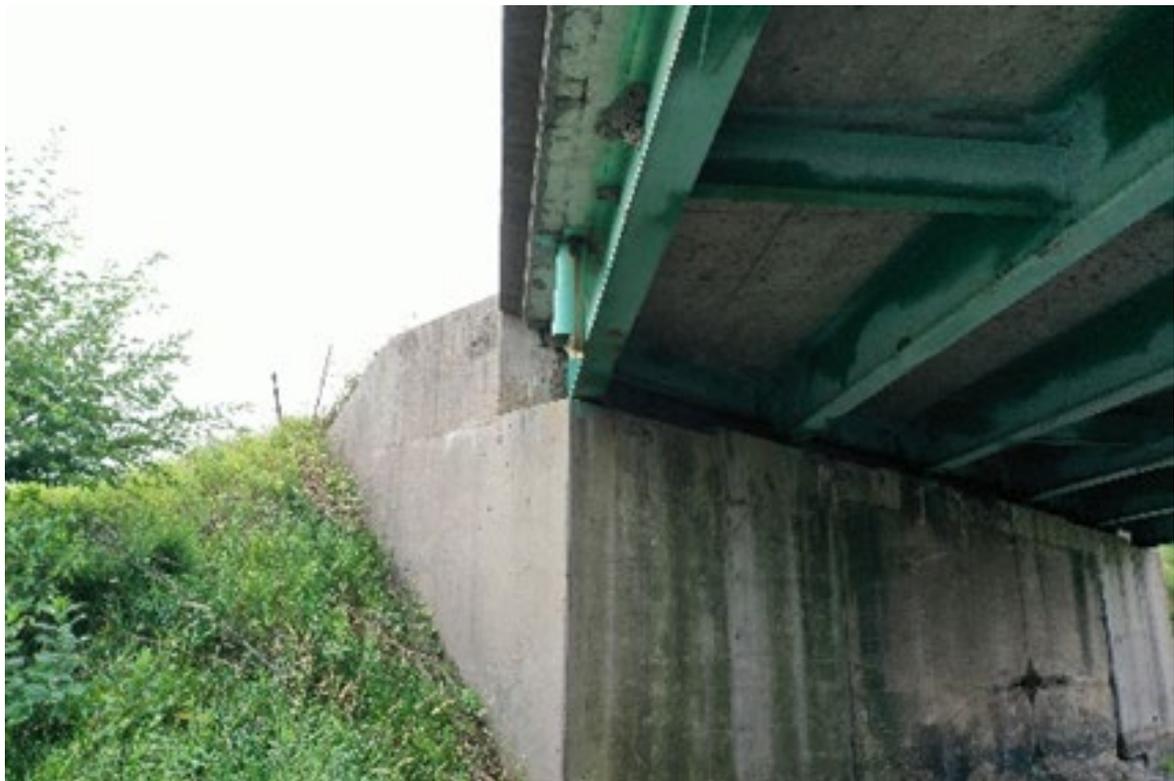
**Figures 4.1. Example of bridge substructure image before annotation**

Using Roboflow to annotate images involved multiple steps. First, the images were uploaded to Roboflow by creating a new project. Then, the type of annotation needed for the project was selected, such as bounding boxes or polygons. Next, each image was manually annotated, for example, by drawing boxes around objects and labeling them with the types of defects. After all of the images were annotated, the annotated data were exported in several formats that suited the needs of this project. This exported data were then ready for training or testing machine learning models. Figures 4.1 and 4.2 present examples of images before and after annotation.

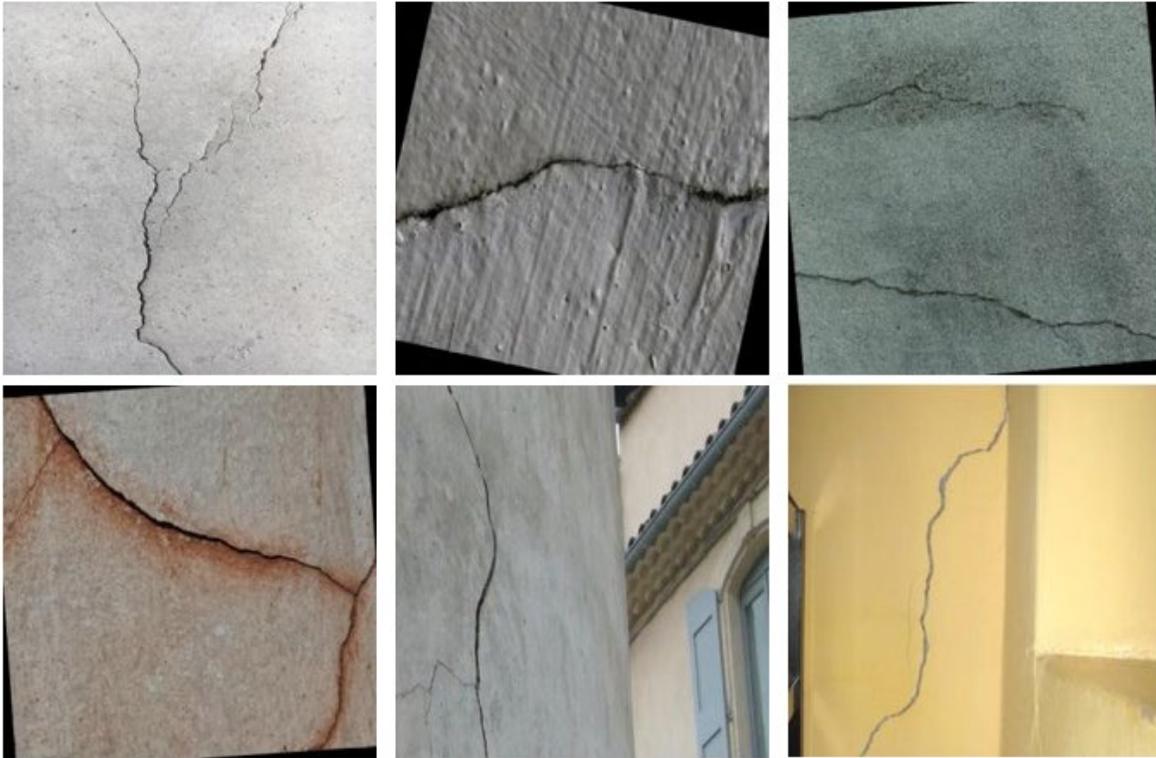
**Figure 4.7. Pre-annotated images for cracks in concrete (various backgrounds and distances)**

curve, enabling quick adaptation to the intricacies of defect identification. Figures 4.7 and 4.8 present pre-annotated images for cracks and spalling in concrete, respectively.

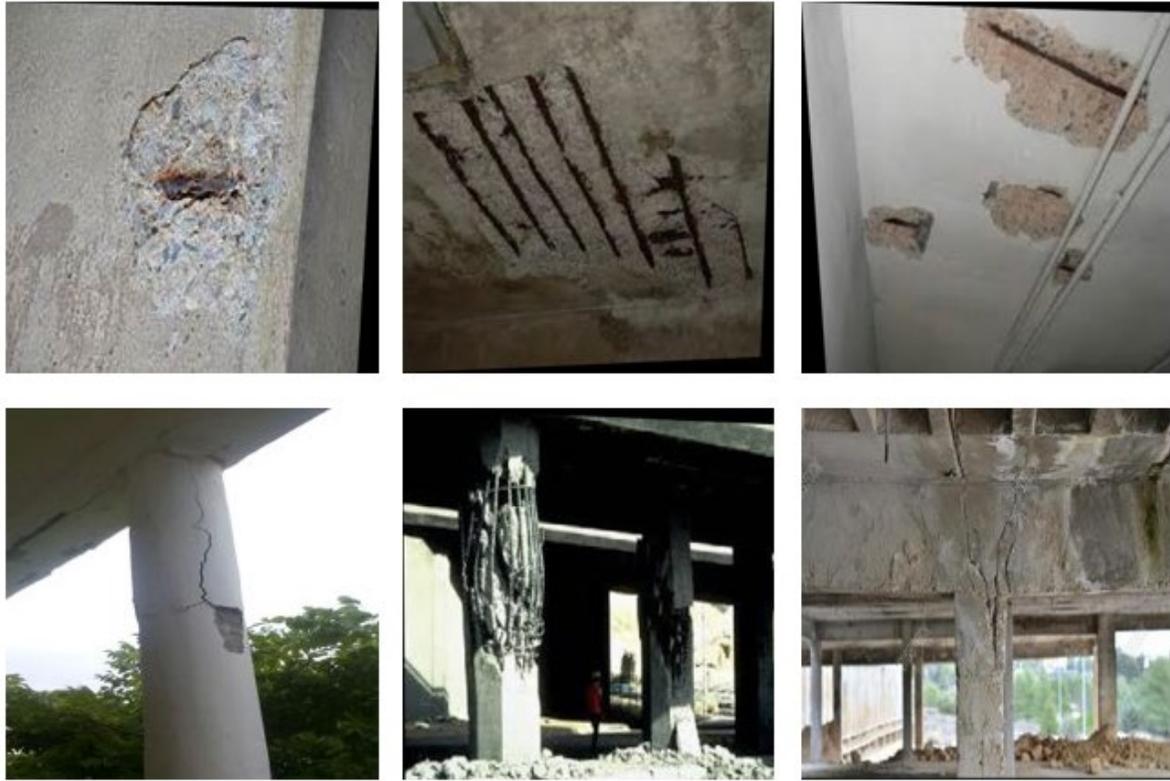
**Figure 4.8. Pre-annotated images for concrete spalling (various backgrounds and distances)**

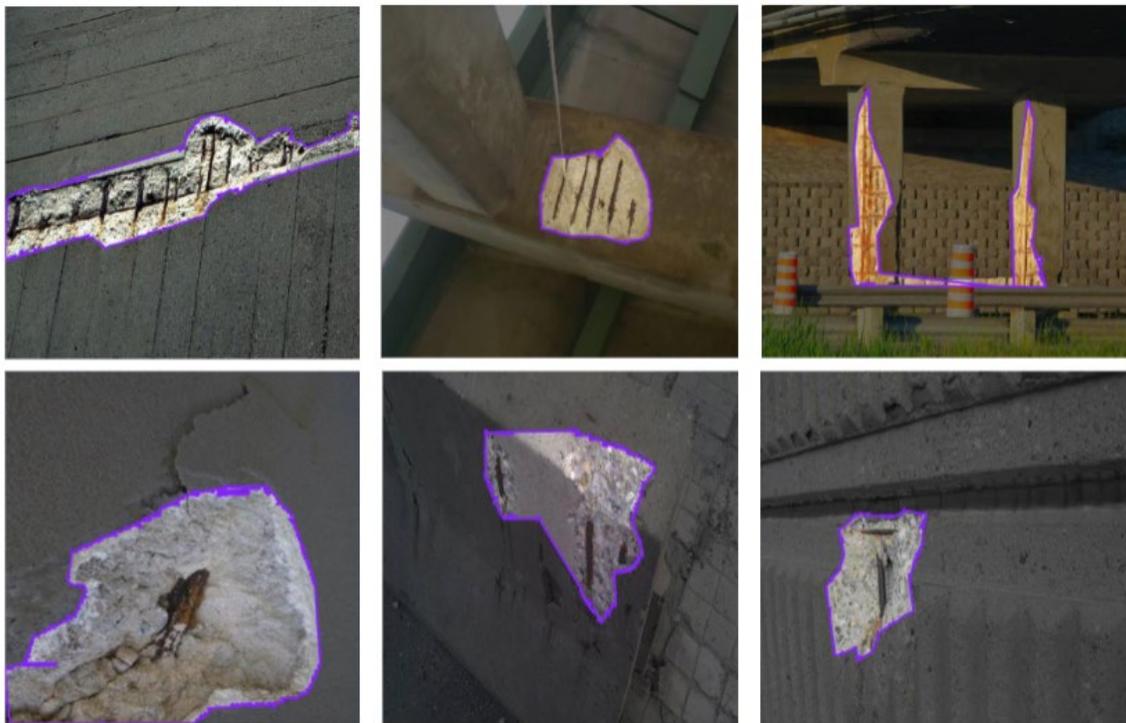
**Figure 4.10. Annotated images for concrete spalling**

A variety of backgrounds, such as concrete, asphalt, and painted walls, were included in the dataset to help the model learn to identify objects irrespective of the background. This approach is crucial for real-world applications where objects are encountered in various settings. The introduction of different backgrounds exposed the model to varying levels of noise and clutter, challenging it to focus on the relevant features of the objects of interest. As a result, the model's ability to distinguish between foreground objects and background was improved, reducing the likelihood of false positives or negatives. Furthermore, as shown in Figures 4.7 and 4.8, images were taken from different distances. The inclusion of images taken at varying distances introduced scale and perspective variations, enabling the model to learn how the appearance of objects changes with distance. This variation is particularly important for tasks that require the recognition of objects of the same class but at different scales or orientations. Figures 4.9 and 4.10 present the annotated images for cracks and spalling in concrete, respectively.

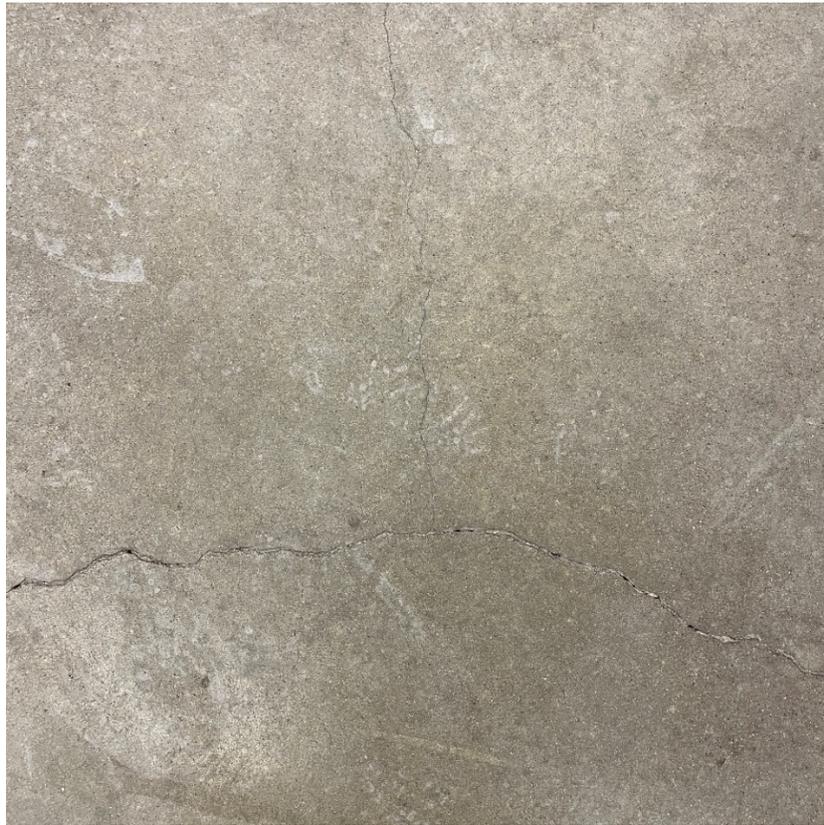
**Figure 4.15. Image of concrete cracks before the image is uploaded to the model**

When high-resolution images are uploaded to the present model, structural deficiencies, particularly cracks and spalling, within concrete surfaces are detected with remarkable accuracy. Utilizing the new image processing layers, the model successfully identifies even the smallest cracks, such as those as narrow as 0.022 in., as demonstrated in Figures 4.15 and 4.16. The precision and sensitivity of this detection are evident, as the model can highlight cracks that are barely visible. For instance, the images in Figures 4.15 and 4.16 show a concrete surface where, from a distance of 4 ft, the naked eye can barely detect any defect, yet the model accurately marks the fine cracks.

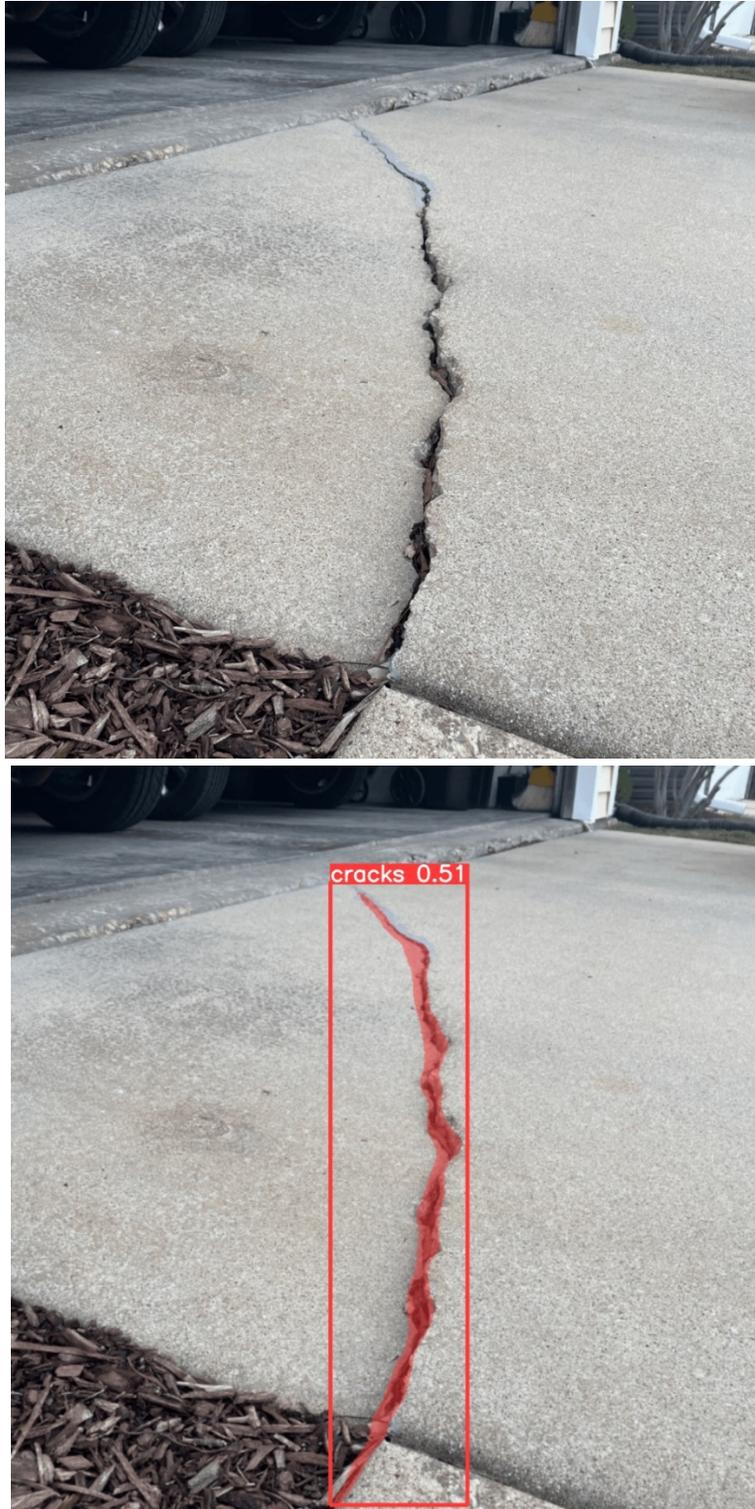
**Figure 4.17. Result of concrete crack detection before and after an image is uploaded to the model**

Figure 4.17 demonstrates the model's advanced detection capabilities from a distance of 15 ft, which exhibits its ability to detect cracks accurately even when the image is taken far from the defects. Moreover, the angle of capture of the image is not directly perpendicular to the crack (not 90 degrees), which highlights the capabilities of the model in processing different distances and angles of capture. The concrete surface in this example is normal concrete, which has a different color and surface texture than the concrete in Figures 4.15 and 4.16. There is also a slightly inclined driveway, which adds to the complexity of detection.

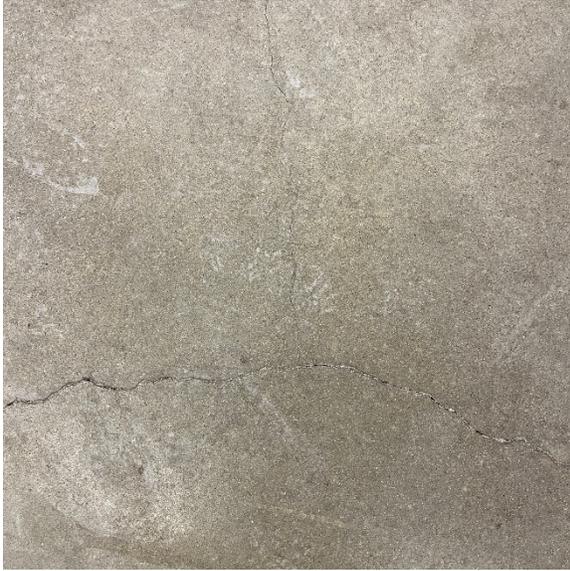
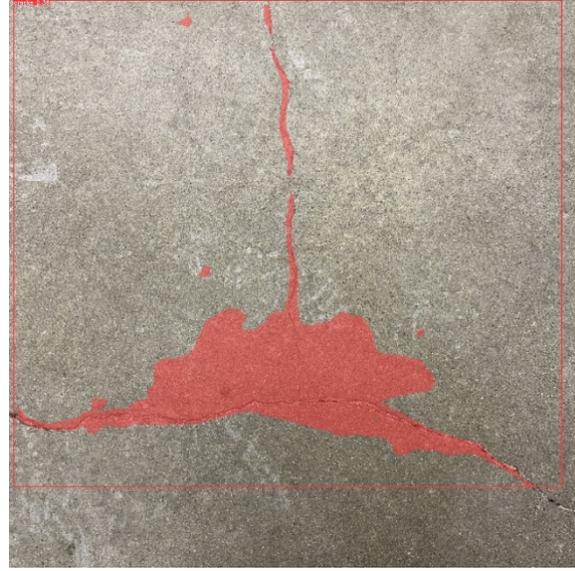
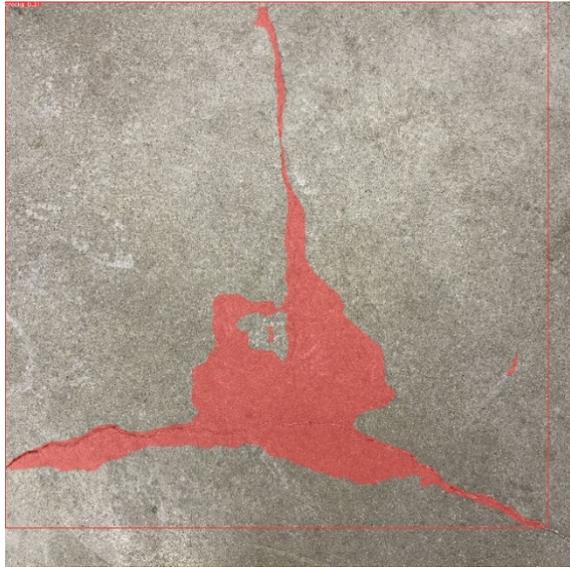
The process of enhancing the proposed model's predictive capabilities through fine-tuning yielded extraordinary improvements in damage detection. As can be observed from the progression illustrated in Figure 4.21, there was a significant evolution from initial inaccurate detection to highly precise identification of structural defects. This improvement was achieved through a comprehensive and iterative fine-tuning process, which involved carefully adjusting various parameters and training the model with diverse images encompassing a wide range of crack widths and spalling conditions. The use of a diverse and augmented dataset was a key aspect of the fine-tuning process. Different augmentation techniques were applied to increase the variety of the training dataset, including rotation within a range of -15 to +15 degrees, random horizontal and vertical flips, brightness and contrast adjustments, and the addition of Gaussian noise. The training dataset was enriched with images featuring concrete spalling of various sizes and depths as well as cracks of several widths and lengths (ranging from hairline cracks to extensive cracks exceeding 1 in.), as described in Section 4.4. This diversity allowed the model to learn to detect and classify cracks across a broad spectrum of sizes. Similarly, multiple types and severities of spalling were included in the dataset, from minor surface deterioration to extensive concrete loss, enabling the model to accurately identify different stages of spalling.
